CITY AND BOROUGH OF WRANGELL BARGE RAMP CONDITION ASSESSMENT

MARCH 2025

PND PROJECT No. 252032

Subject: Wrangell Barge Ramp – Condition Assessment

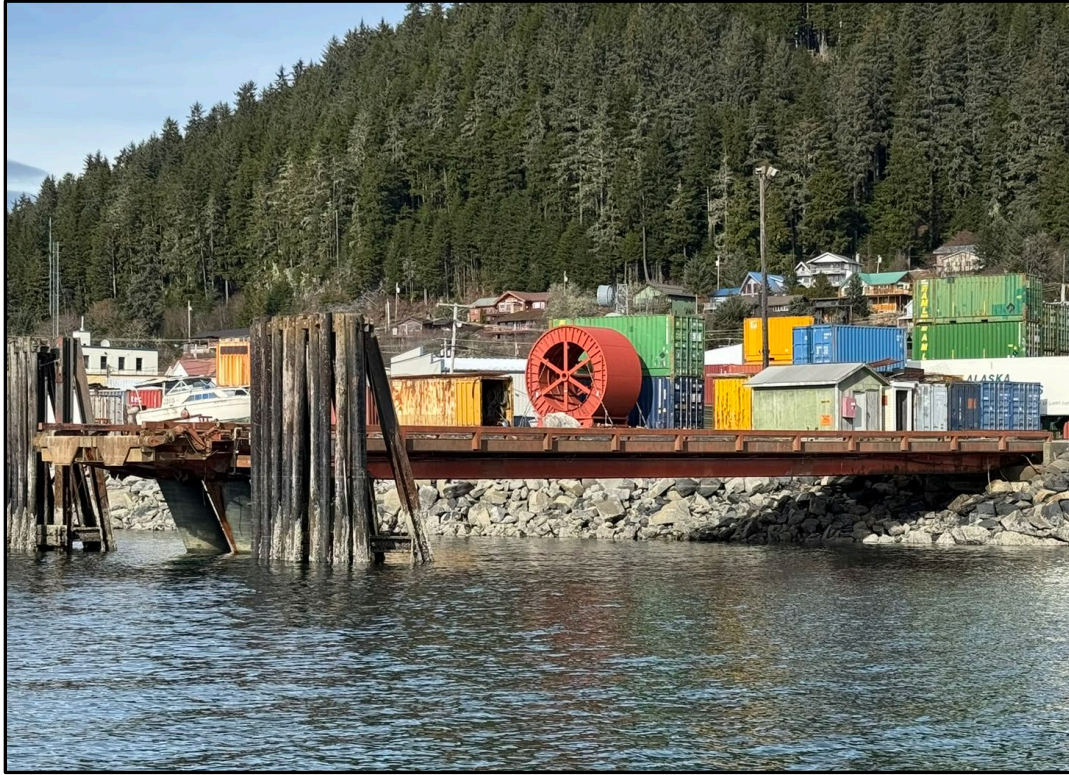
FIGURE 1. Overall view (south side looking north) of barge ramp.

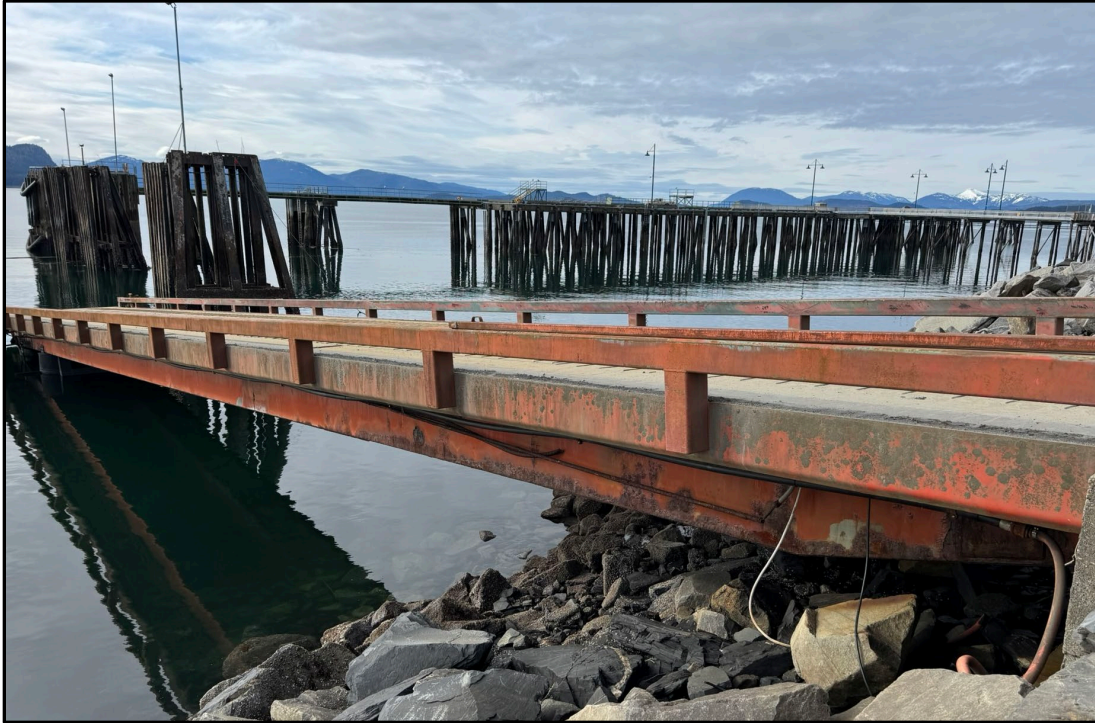
In addition, the barge ramp was observed to be bent (i.e. negative curvature from ramp self weight only), likely due to being overloaded. Typically, bridges of this length are fabricated with a positive “camber” of 2-3 inches above horizontal. A string line run along the barge ramp revealed a negative camber of slightly over 1 inch. On site was a steel electrical cable spool (see photos) nearly the height of two stacked shipping containers. This, along with the capacity of steel flats (38 tons maximum gross weight) and containers (45 tons maximum gross weight), would far exceed the barge ramp safe load capacity stipulated in the 2011 load analysis when transported by the forklifts currently on site. According to the equipment data plates, the forklifts weigh approximately 77 tons total, with 46 tons on the front axle and 31 tons on the rear (steering) axle. The combined total on the front axle with either a flat or container at its maximum gross weight would be more than 80 tons which is significantly greater than the 70-ton axle and 77-ton total forklift vehicle weight load limit currently posted on the barge ramp.

FIGURE 2. Profile of the barge ramp (south side).

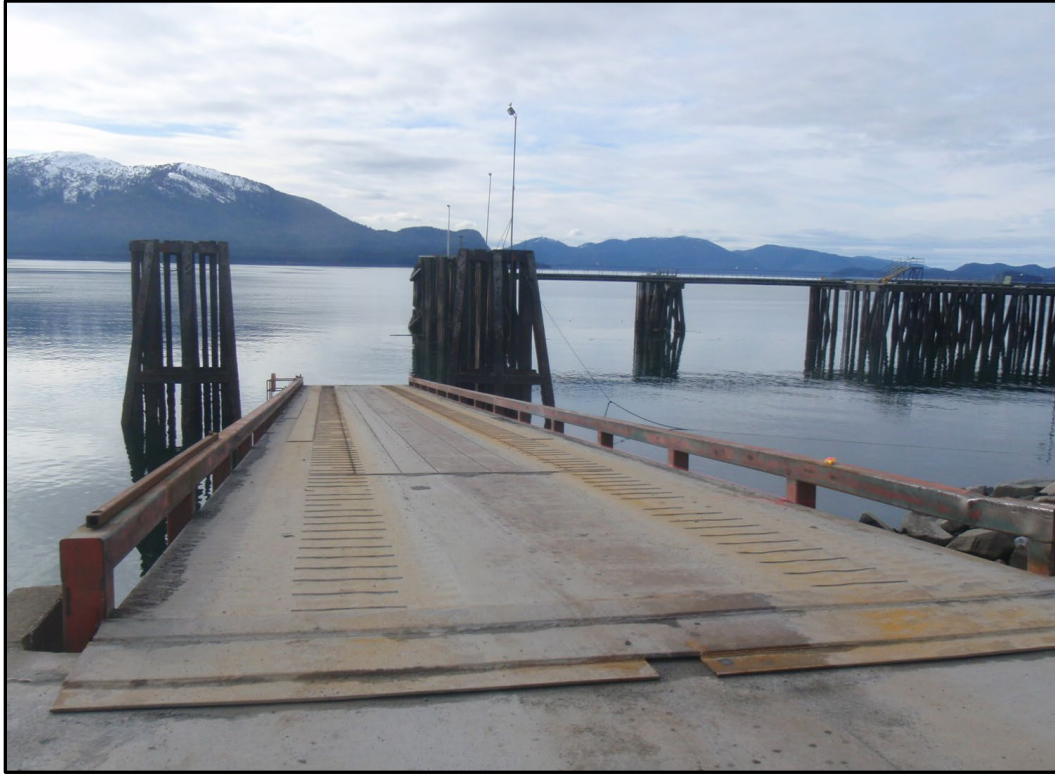
FIGURE 3. Barge ramp deck looking ramp from abutment.

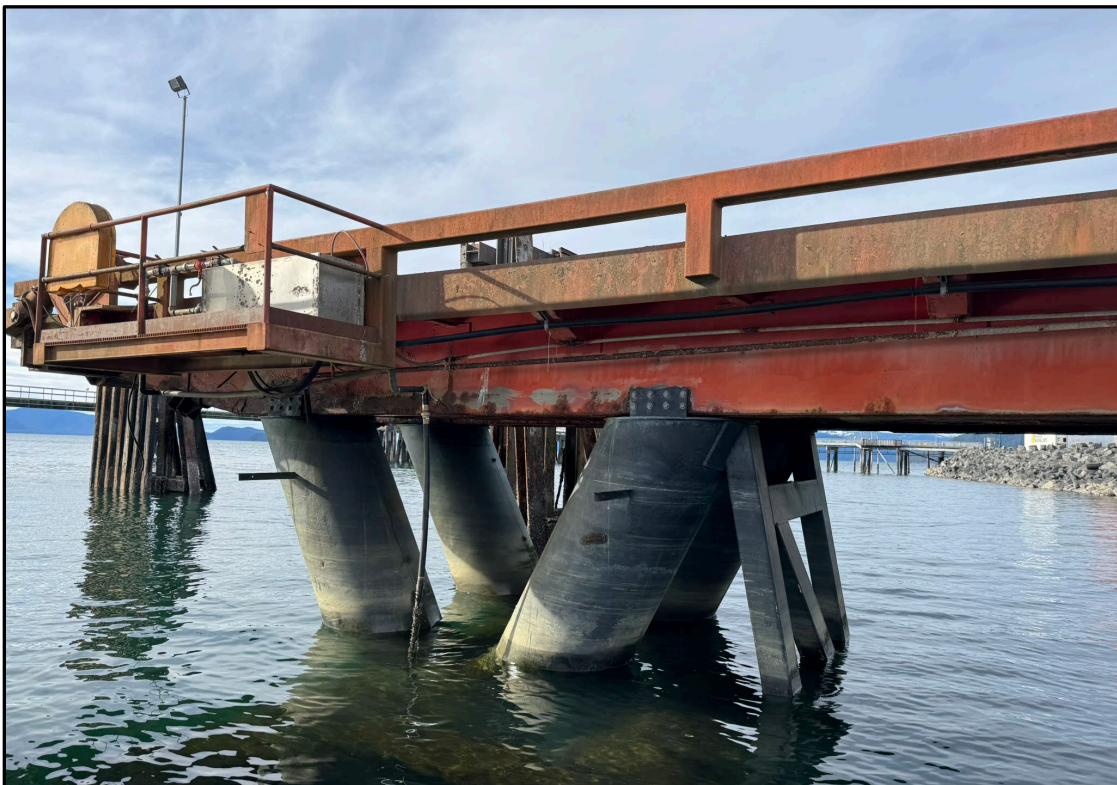
FIGURE 4. Floatation tank operation platform and ramp connection struts (south side).

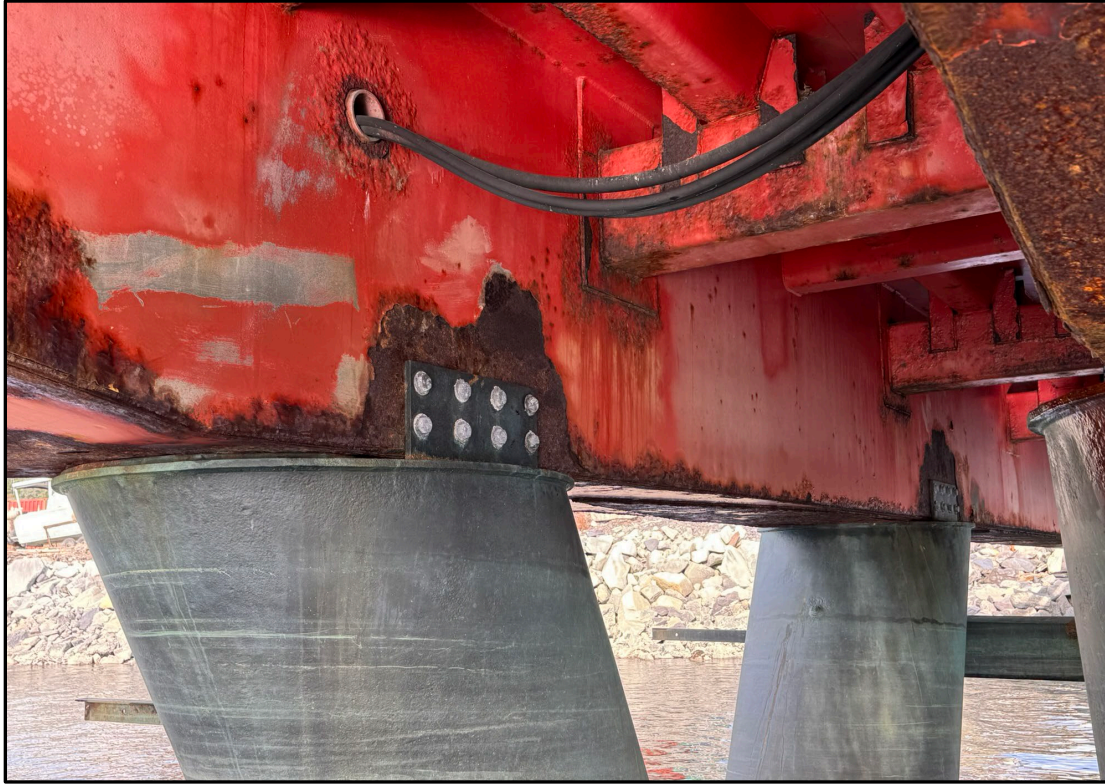
FIGURE 5. Flotation tank connection plates with new bolts.

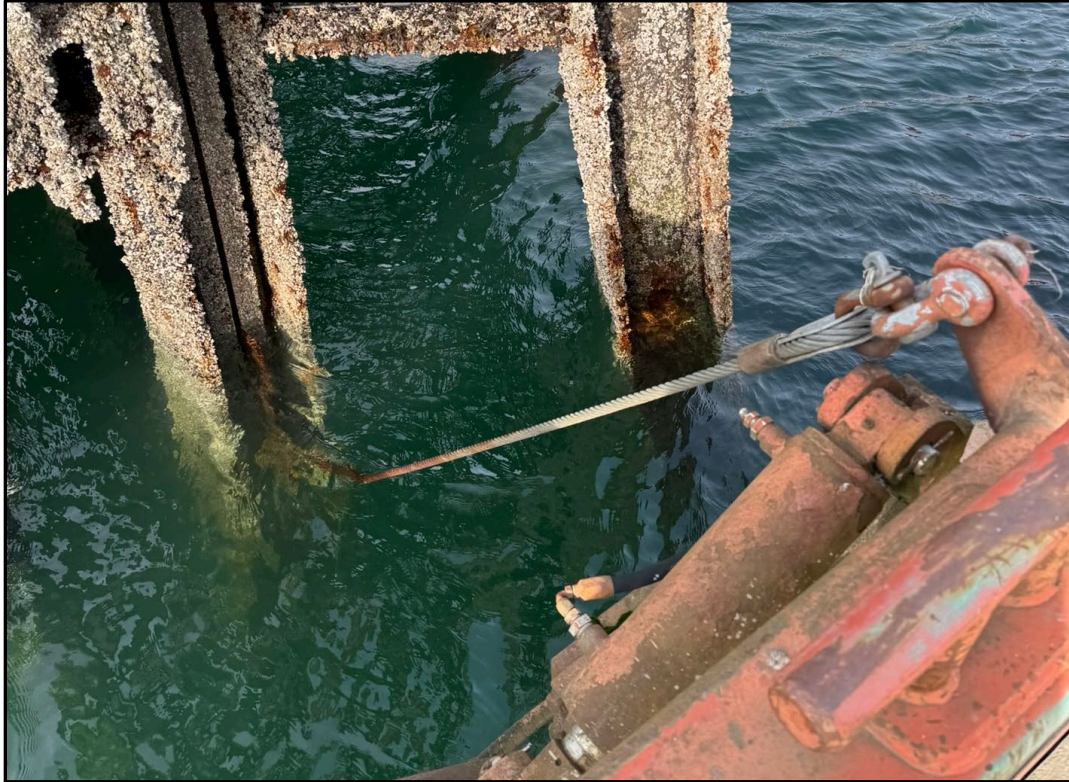
FIGURE 6. Tether cable on north side of barge ramp.

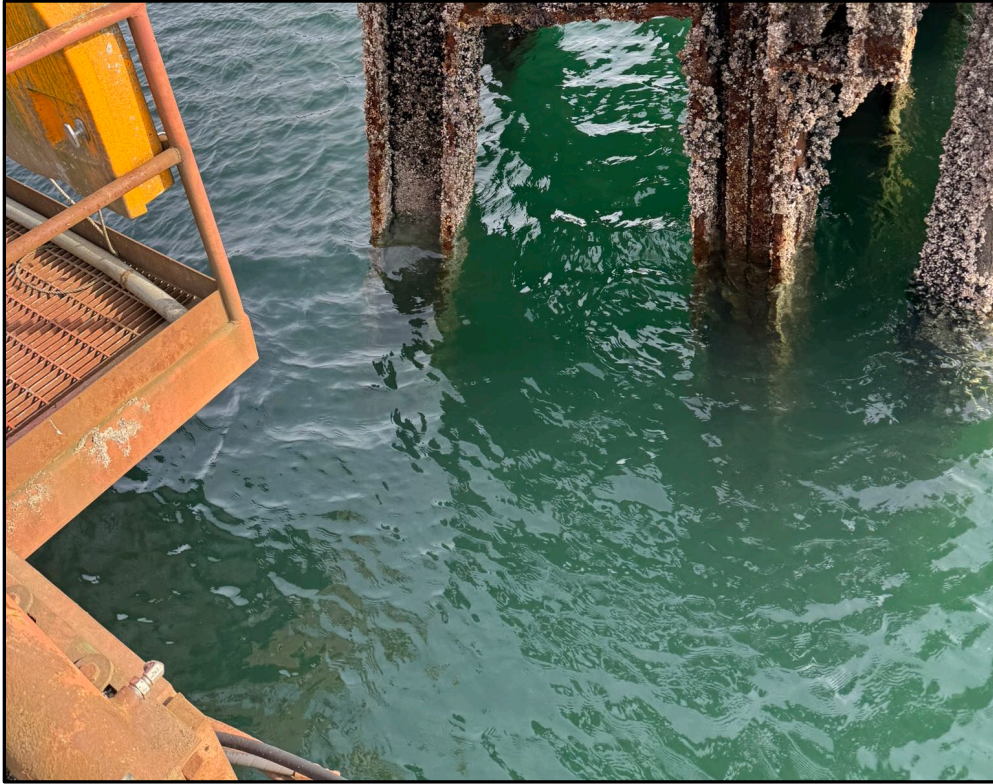
FIGURE 7. Tether cable missing/detached from barge ramp on south side.

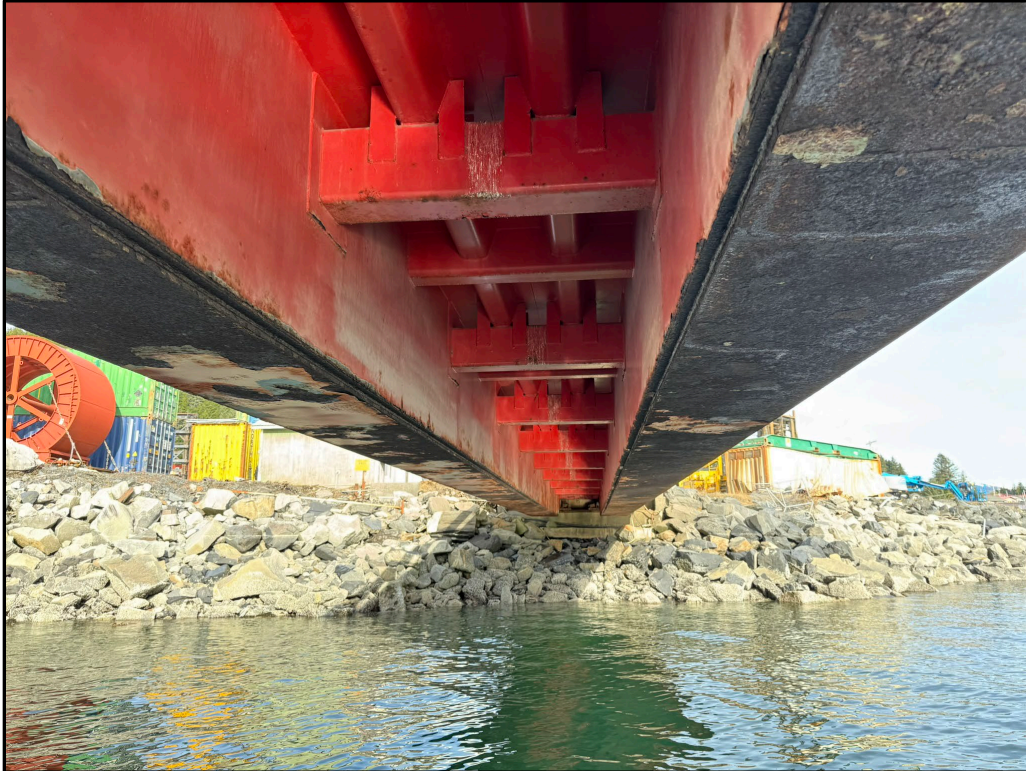
FIGURE 8. Bottom flange of barge ramp girders, looking shoreward from floatation tank.

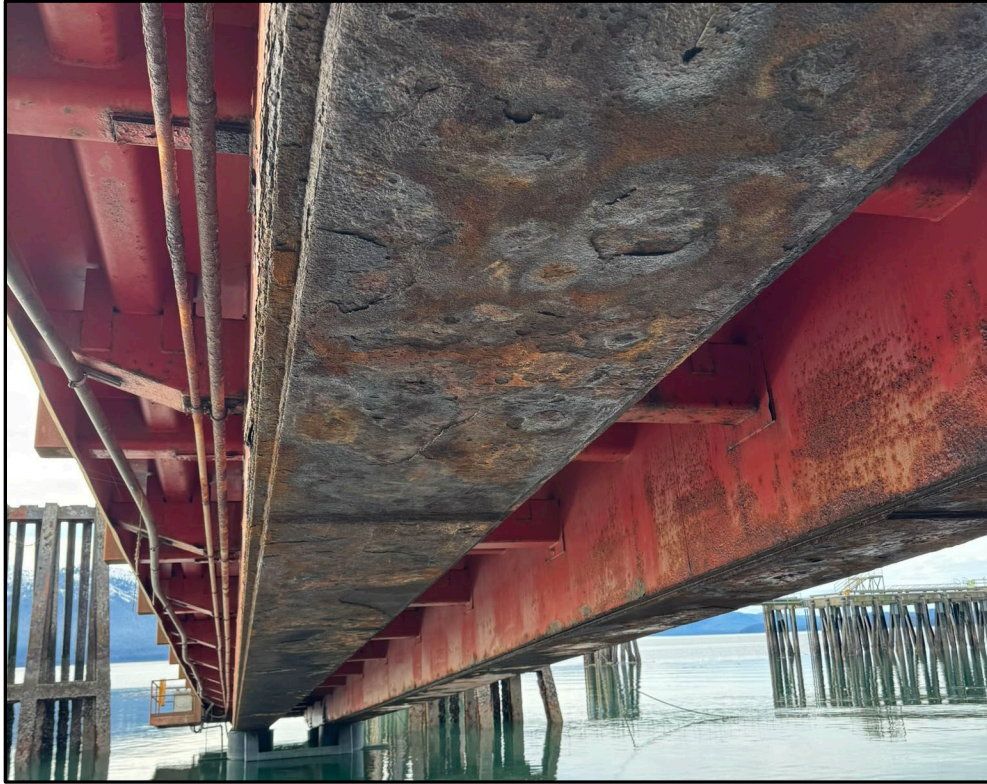
- Barge Ramp Superstructure - Overall condition of the barge ramp steel elements is poor. In the 2011 report, condition of the paint coating system was noted as poor, particularly on the underside of the main box-girders where a significant amount of surface corrosion was documented. With a compromised coating system and daily exposure to salt spray, the level of corrosion has notably increased on all ramp elements. In particular, corrosion of the box-girder bottom flanges has progressed extensively and varies from “moderate” to “severe” as defined by the ASCE Guide *“Waterfront Facilities Inspection and Assessment”*. This means the steel exhibits extensive pitting and localized section loss (i.e. flaking) from laminar corrosion (layered appearance of steel easily removable by hand – see photos).

FIGURE 9. Typical barge ramp girder bottom flange – coating loss and laminar corrosion.

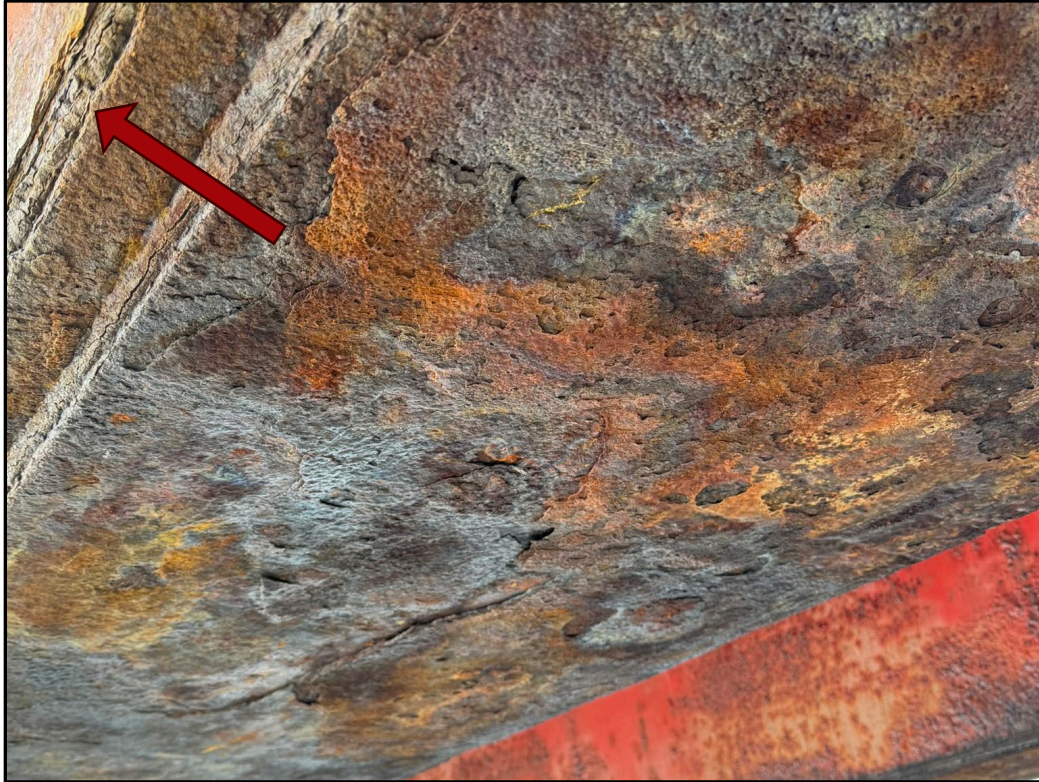
Most importantly, while condition varies along the length of each girder, significant portions of the bottom flange-to-web structural welds also exhibit this high level of corrosion. This condition represents a greater structural concern, particularly in an overload situation. If the deteriorated welds crack due to overstress and a crack propagates along the girder length, the box-girder webs could eventually separate from the bottom flange, leading to failure of a girder and the barge ramp.

FIGURE 10. Close-up of laminar corrosion and deteriorated weld on barge ramp girder bottom

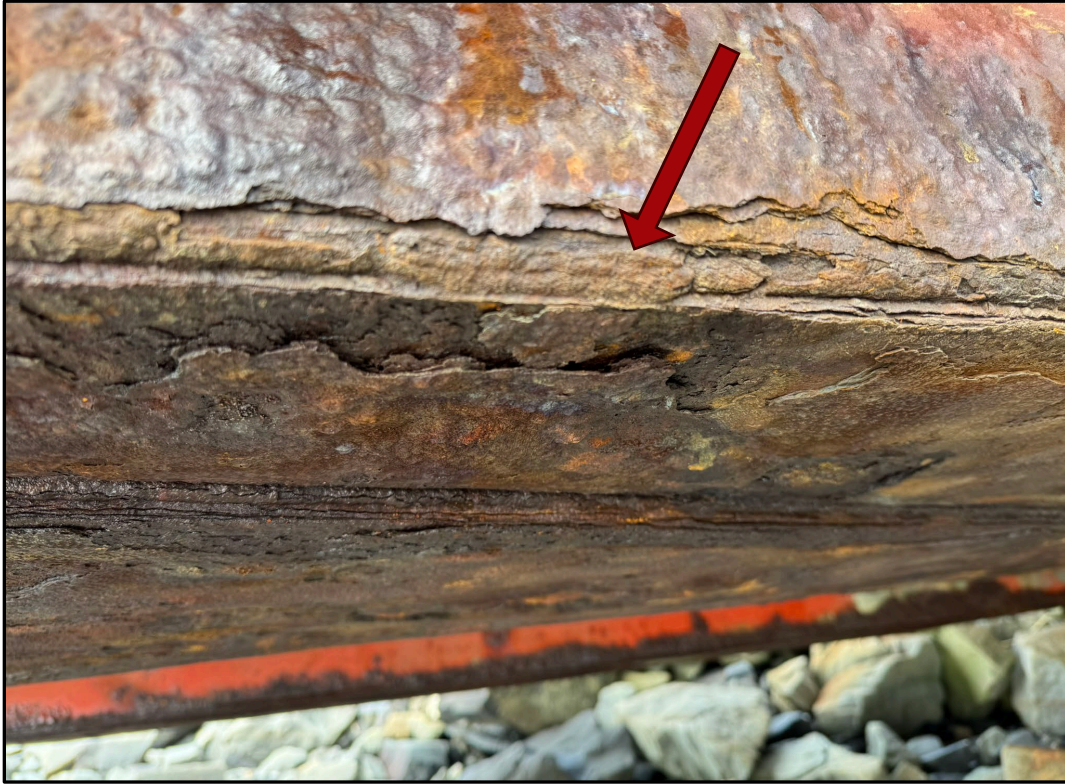
FIGURE 11. Corrosion and loss of weld material along bottom flange edge at web junction.

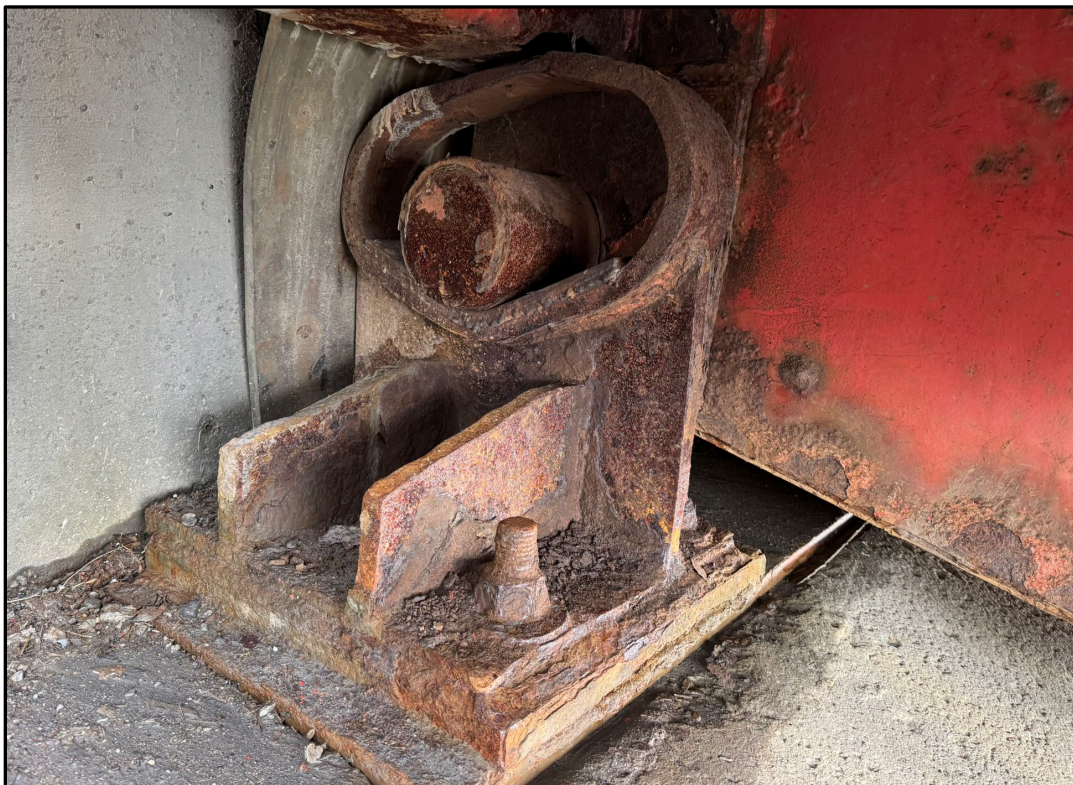
- Abutment - The steel bridge bearing assemblies appear to be functioning adequately; however, protective coatings have been completely gone for many years and the steel components have varying levels of corrosion. All plate steel has a moderate level of corrosion with some flaking, while the bearing assembly anchor bolts are corroded to the extent that the threads are barely visible and the anchor bolt nuts no longer have sharp edges but instead are “conical” shaped. “Doubler” plates have been added on the bottom surface of each bearing saddle due to the extent of mechanical wear that had resulted in the elevation of the barge ramp deck dropping below the elevation of the concrete abutment and upland approach.

FIGURE 12. Corrosion at abutment bearing assembly; deformed/repared saddle bearing.

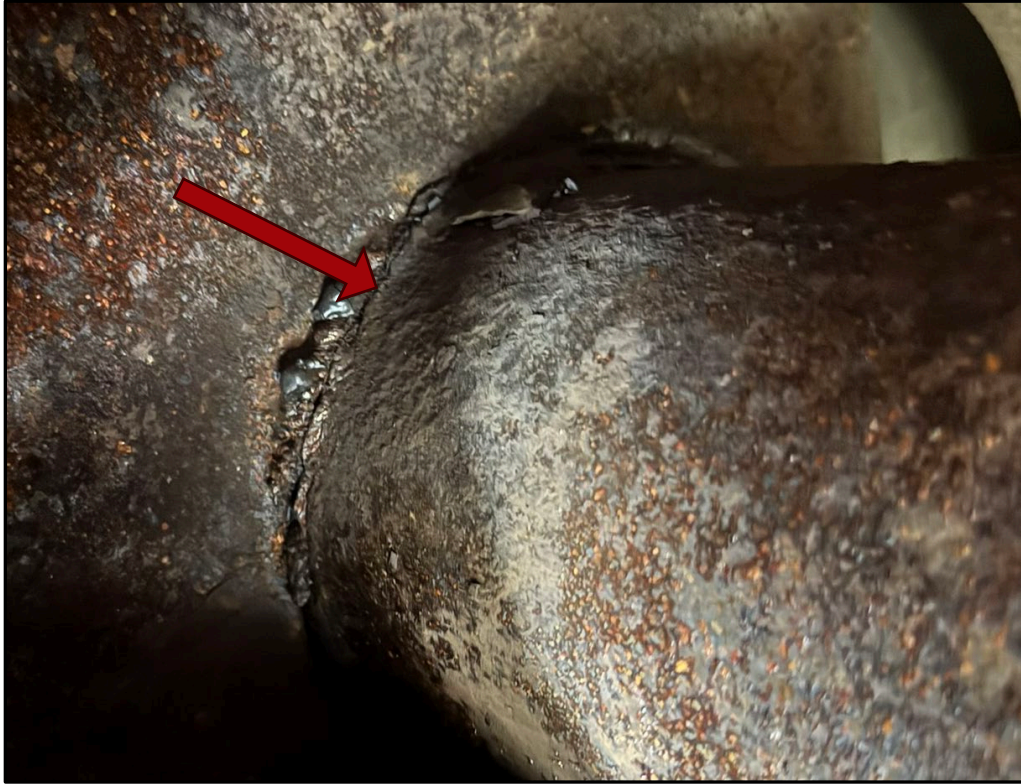
FIGURE 13. Cracked repair weld at abutment bearing pivot pipe.

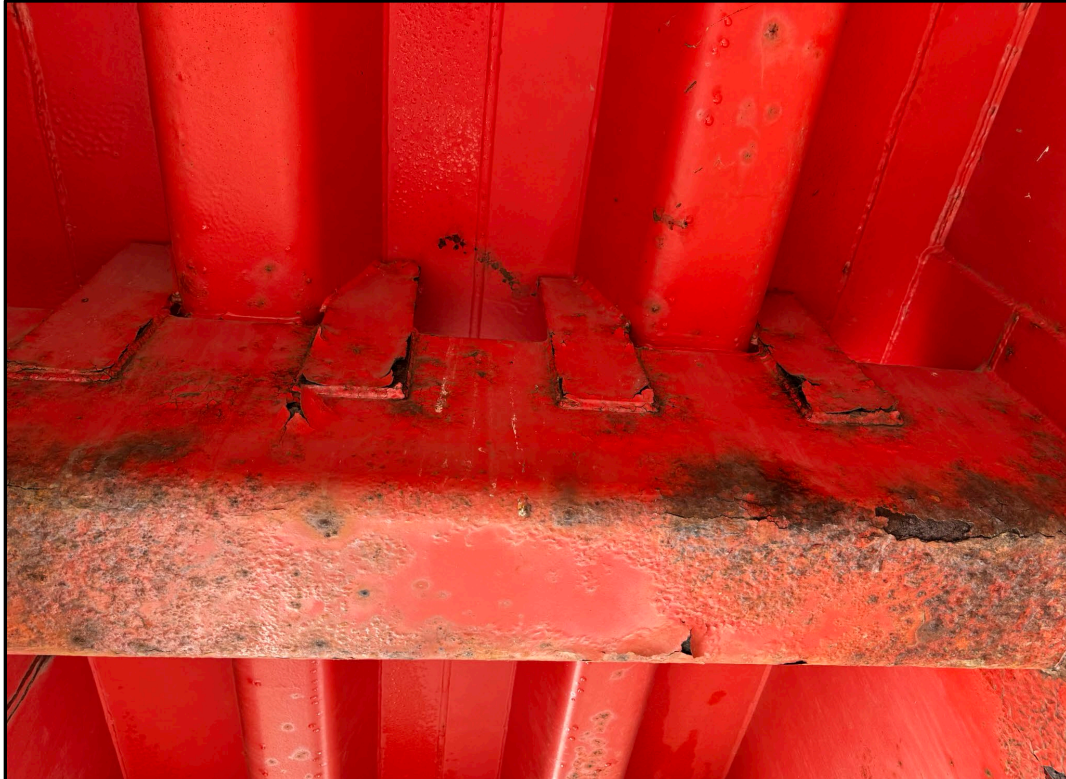
FIGURE 14. Typical coating failure and advanced corrosion of ramp floor beam.

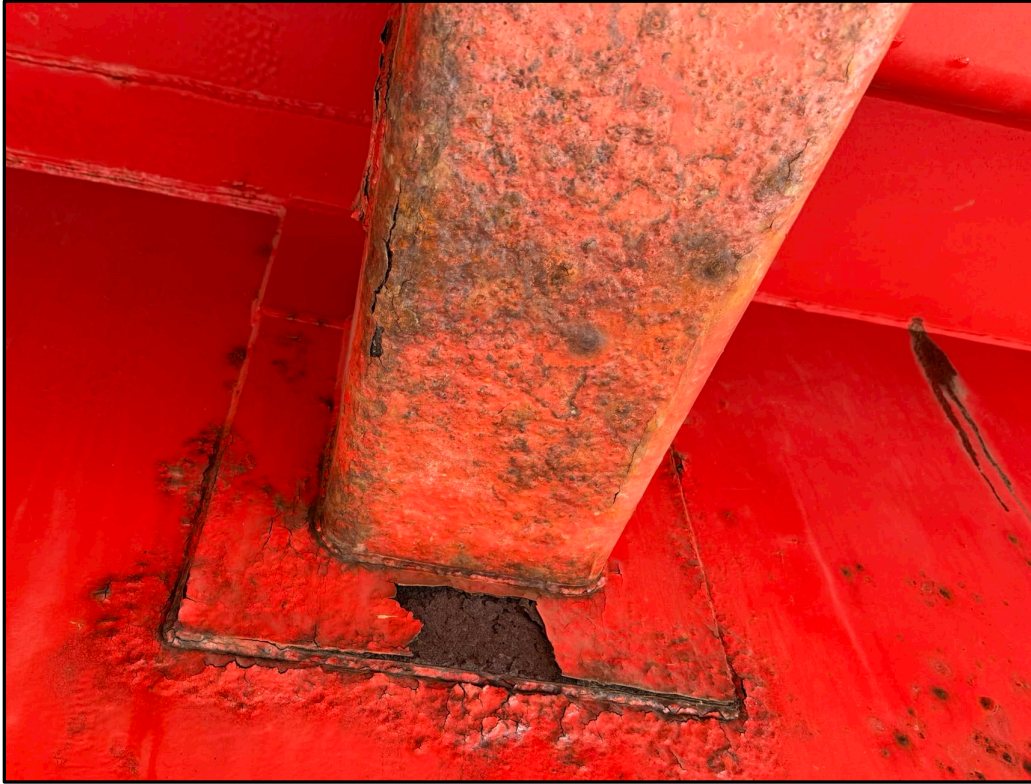
FIGURE 15. Close-up of advanced corrosion at typical floor beam connection.

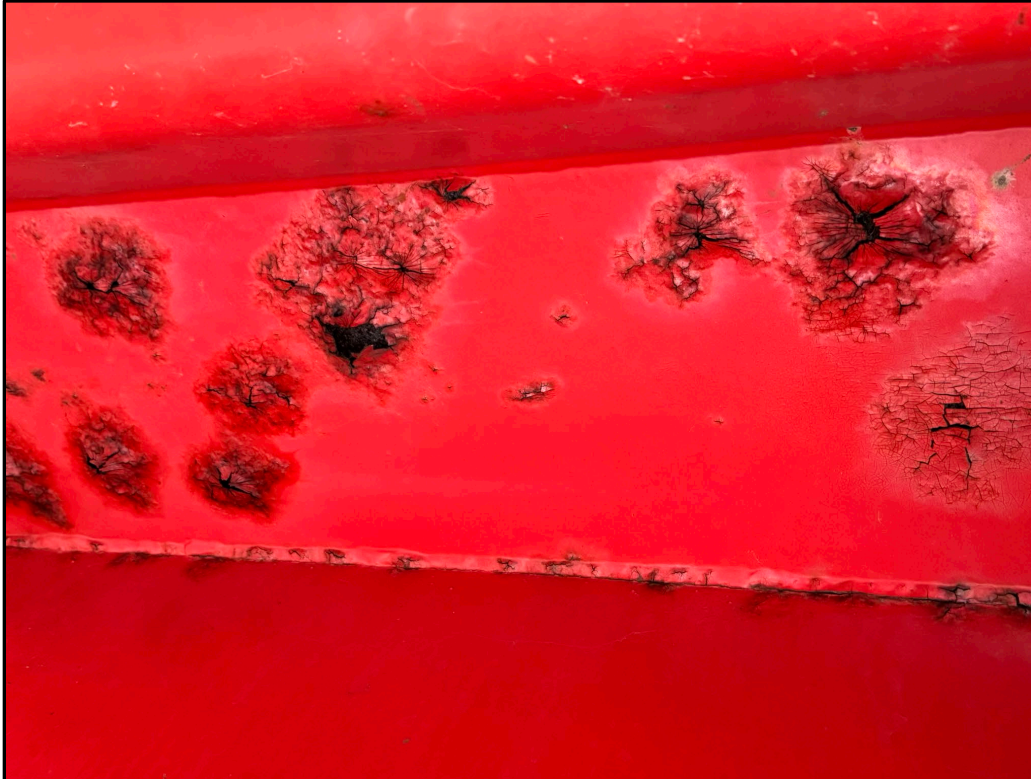
FIGURE 16. Typical blistering of deck plate (underside) between deck ribs.

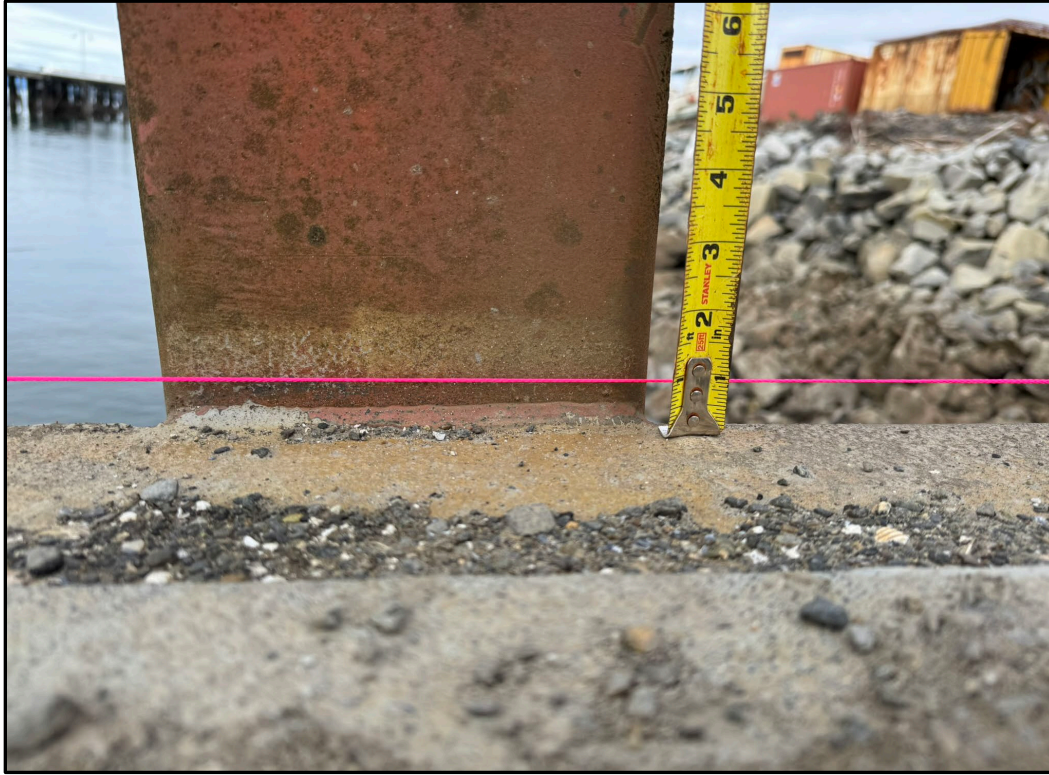
Overstress (beyond yield strength of the material) of a structure with full-thickness of steel and full-strength of welds will result in permanent deformation (i.e. structure being bent). On the other hand, overstress of a structure with reduced steel thickness will result in permanent deformation at a lower load, and a structure with less than full-strength welds has the potential for failure.

FIGURE 17. Sag at mid-span of the barge ramp (i.e. ramp bent due to overloading).

recommendations include reducing the current magnitude and frequency of operational loads to the greatest extent possible, and consideration be given for different means/methods of freight handling and/or an alternative location for freight operations (i.e. pass/pass at concrete dock adjacent to boat lift). If the loss of girder flange steel thickness due to corrosion is quantified as a uniform 1/8-inch, then the ramp capacity would be reduced to approximately 96% of the original capacity. This equates to a maximum axle load of 67 tons and a total forklift vehicle weight of 74 tons.

Long-term recommendations would include substantial refurbishment or full replacement of the barge ramp. With the current equipment and anticipated loads, a new barge ramp with greater capacity would be a more feasible option.

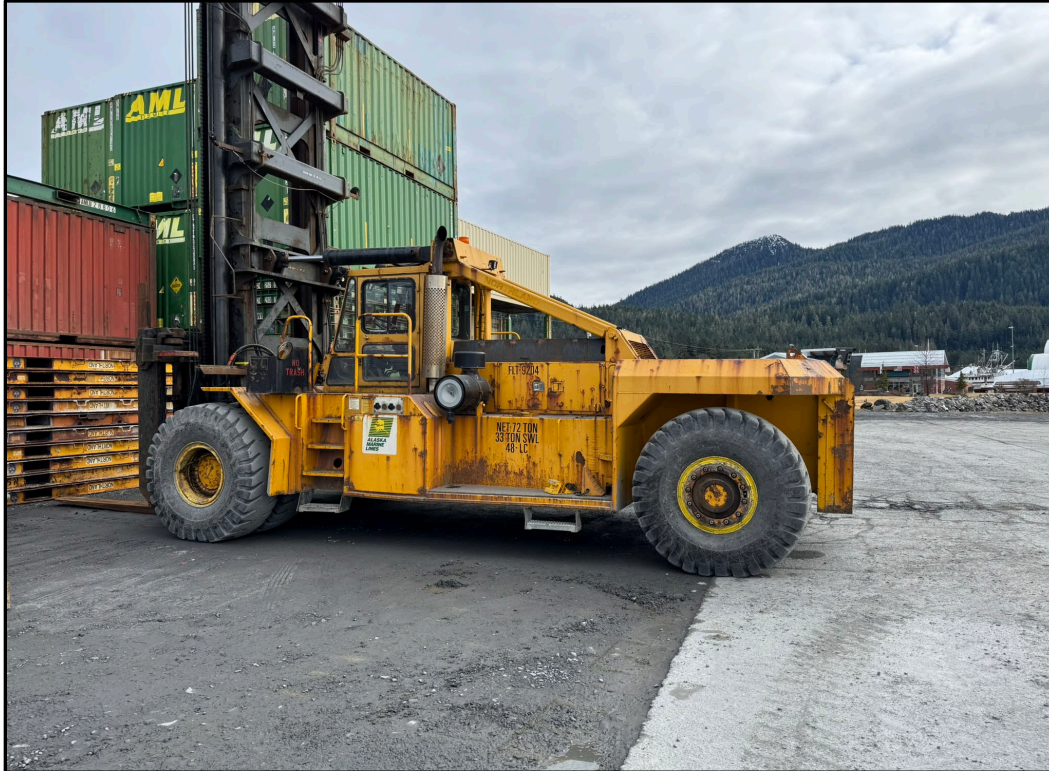
FIGURE 18. Forklift used for handling freight; 77 ton weight; 33 ton safe working load.

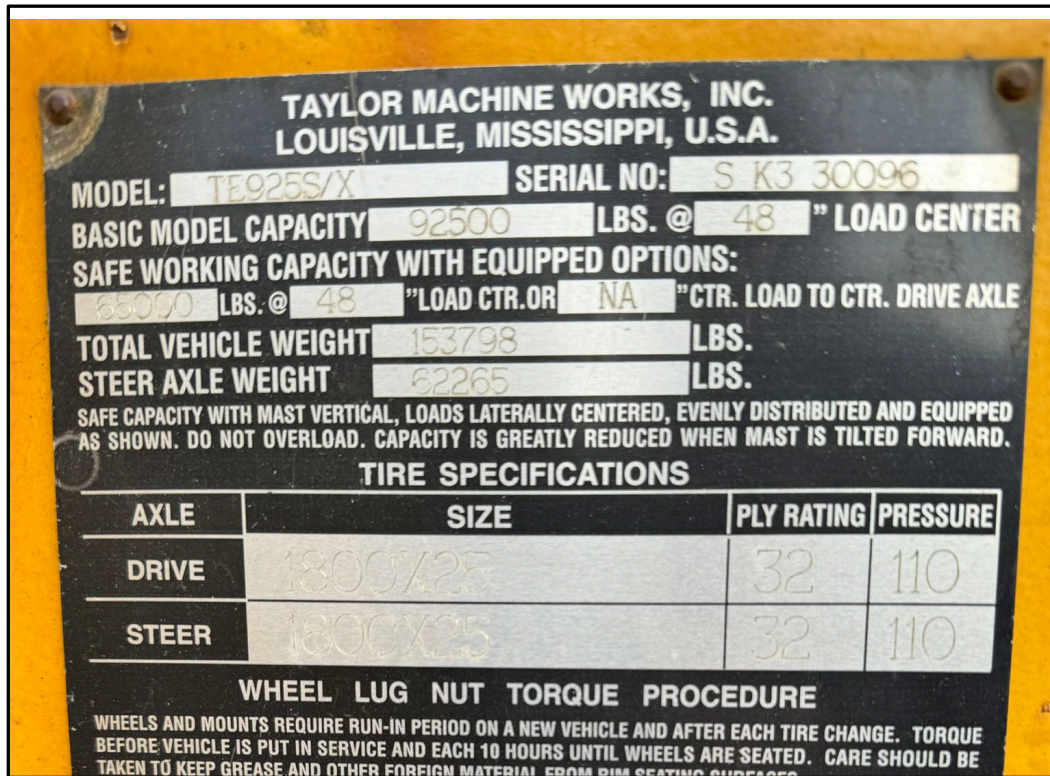
FIGURE 19. Data plate on forklift with weight and lifting capacity.

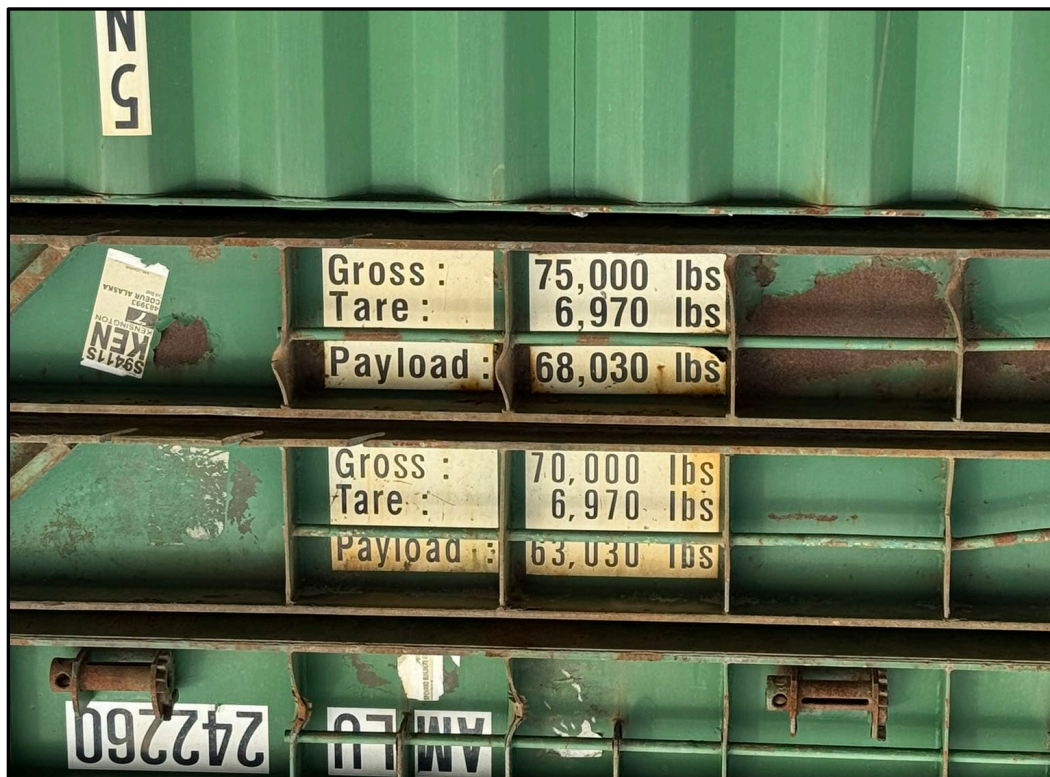
FIGURE 20. Steel flats for handling freight with weight capacities.

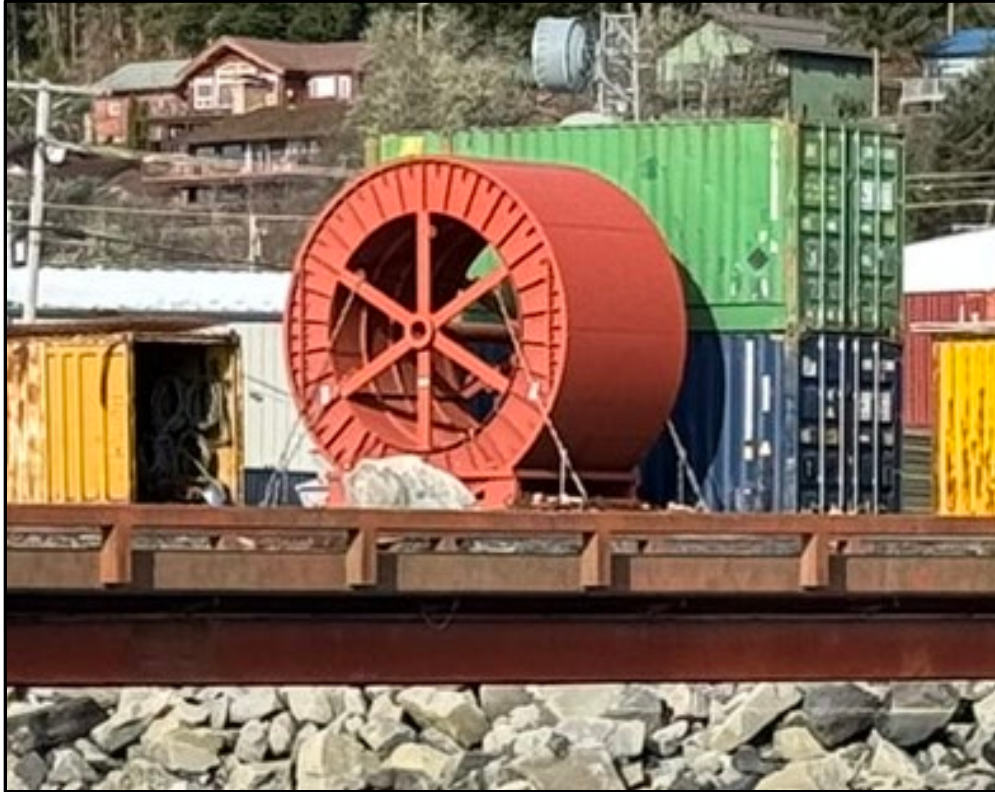
FIGURE 21. Steel electrical cable spool; weight estimated to be over 40 tons.
