CITY & BOROUGH OF WRANGELL

BOROUGH MANAGER'S REPORT

Department of Transportation & Public Facilities Design and Engineering Services - Southcoast Region Materials Section

SUBJECT: SDRER0561– WRG Zimovia
Highway Milepost 11.2 Landslide;
March 2024 Monitoring Summary

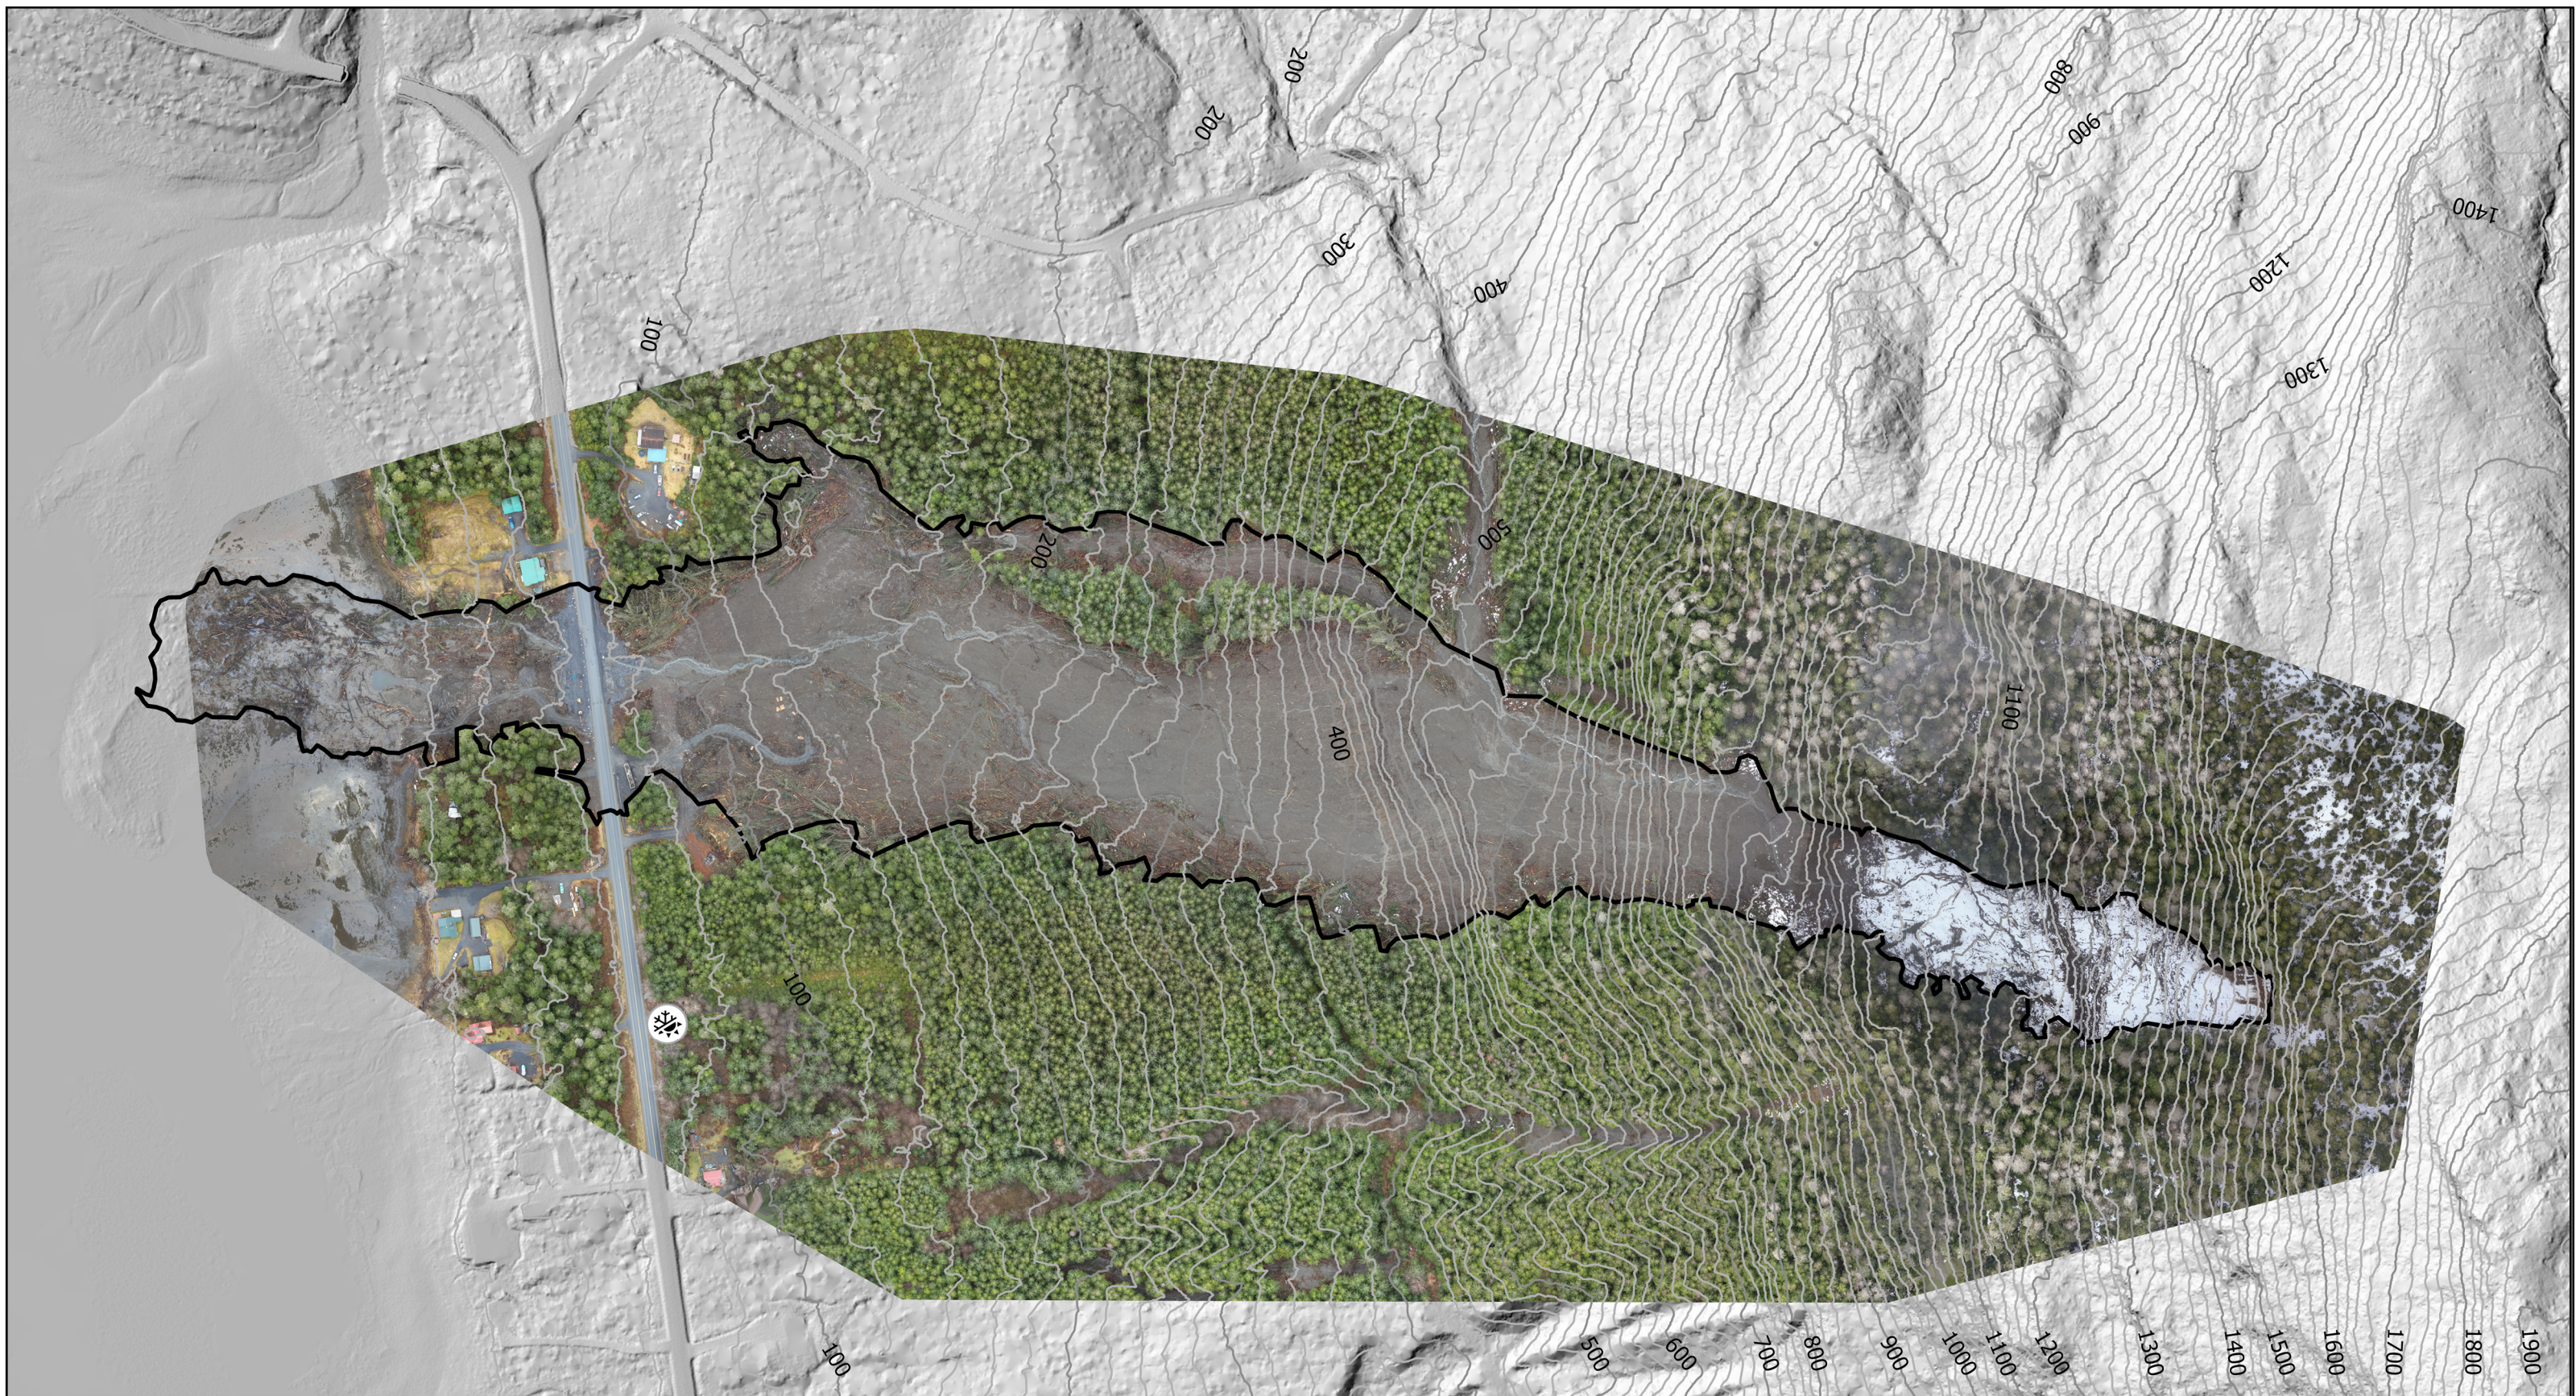
FIGURE 3

MARCH 15, 2024 ORTHOIMAGERY

Table 1 lists orthoimagery mapping missions of the full landslide path successfully completed to date. Based on previous observation, the scheduled orthoimagery mapping mission frequency was reduced to one mapping mission per month or as needed based on precipitation events. Figure 2 shows the initial orthoimagery dataset collected on 11/22/2023. Figure 3 shows the latest orthoimagery dataset collected on 3/15/2024.

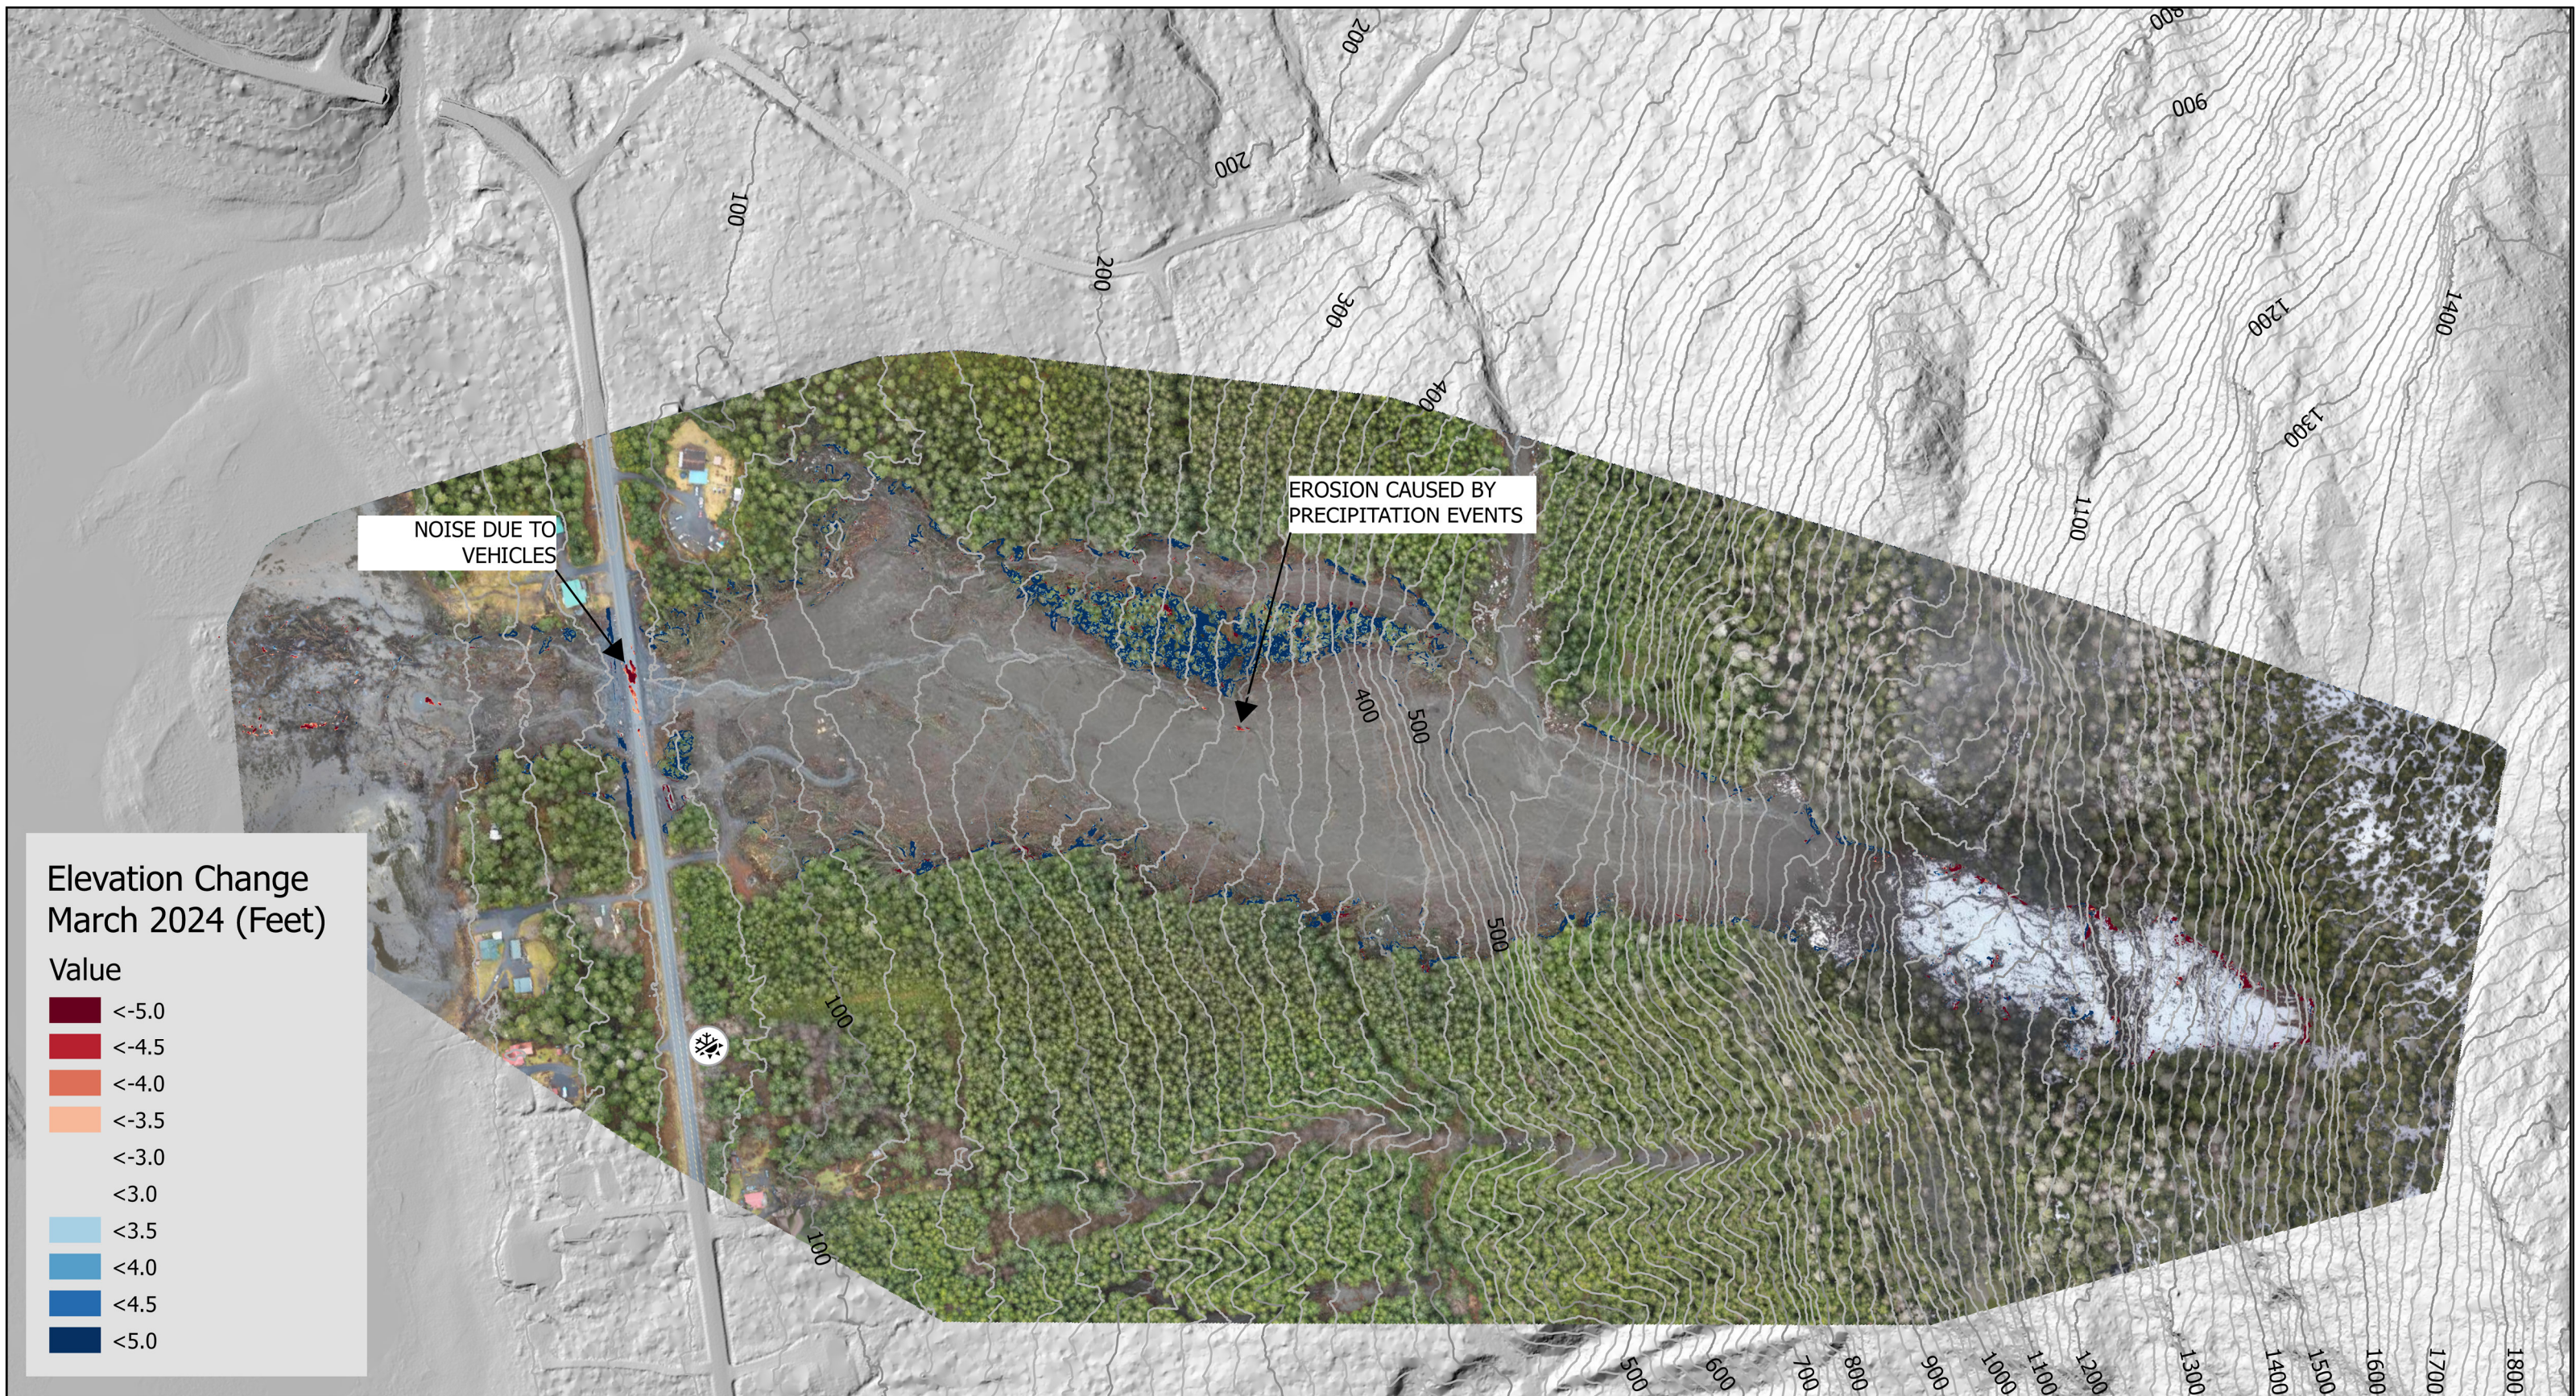
03/15/2024 VS. 02/15/2024 CHANGE DETECTION	
<i>Wrangell Zimovia Highway MP 11.2 Landslide</i>	
	State of Alaska Department of Transportation and Public Facilities Southcoast Region
FIGURE 5

Figure 5 provides the results of a change detection analysis between the 02/15/2024 and 03/15/2024 datasets. This figure highlights the continued erosion of the main stream channel banks within the landslide path. For example, over 5 feet of elevation change due to erosion is shown where the main stream turns west from the logging road, approximately 2,000 feet upstream from Zimovia Highway.

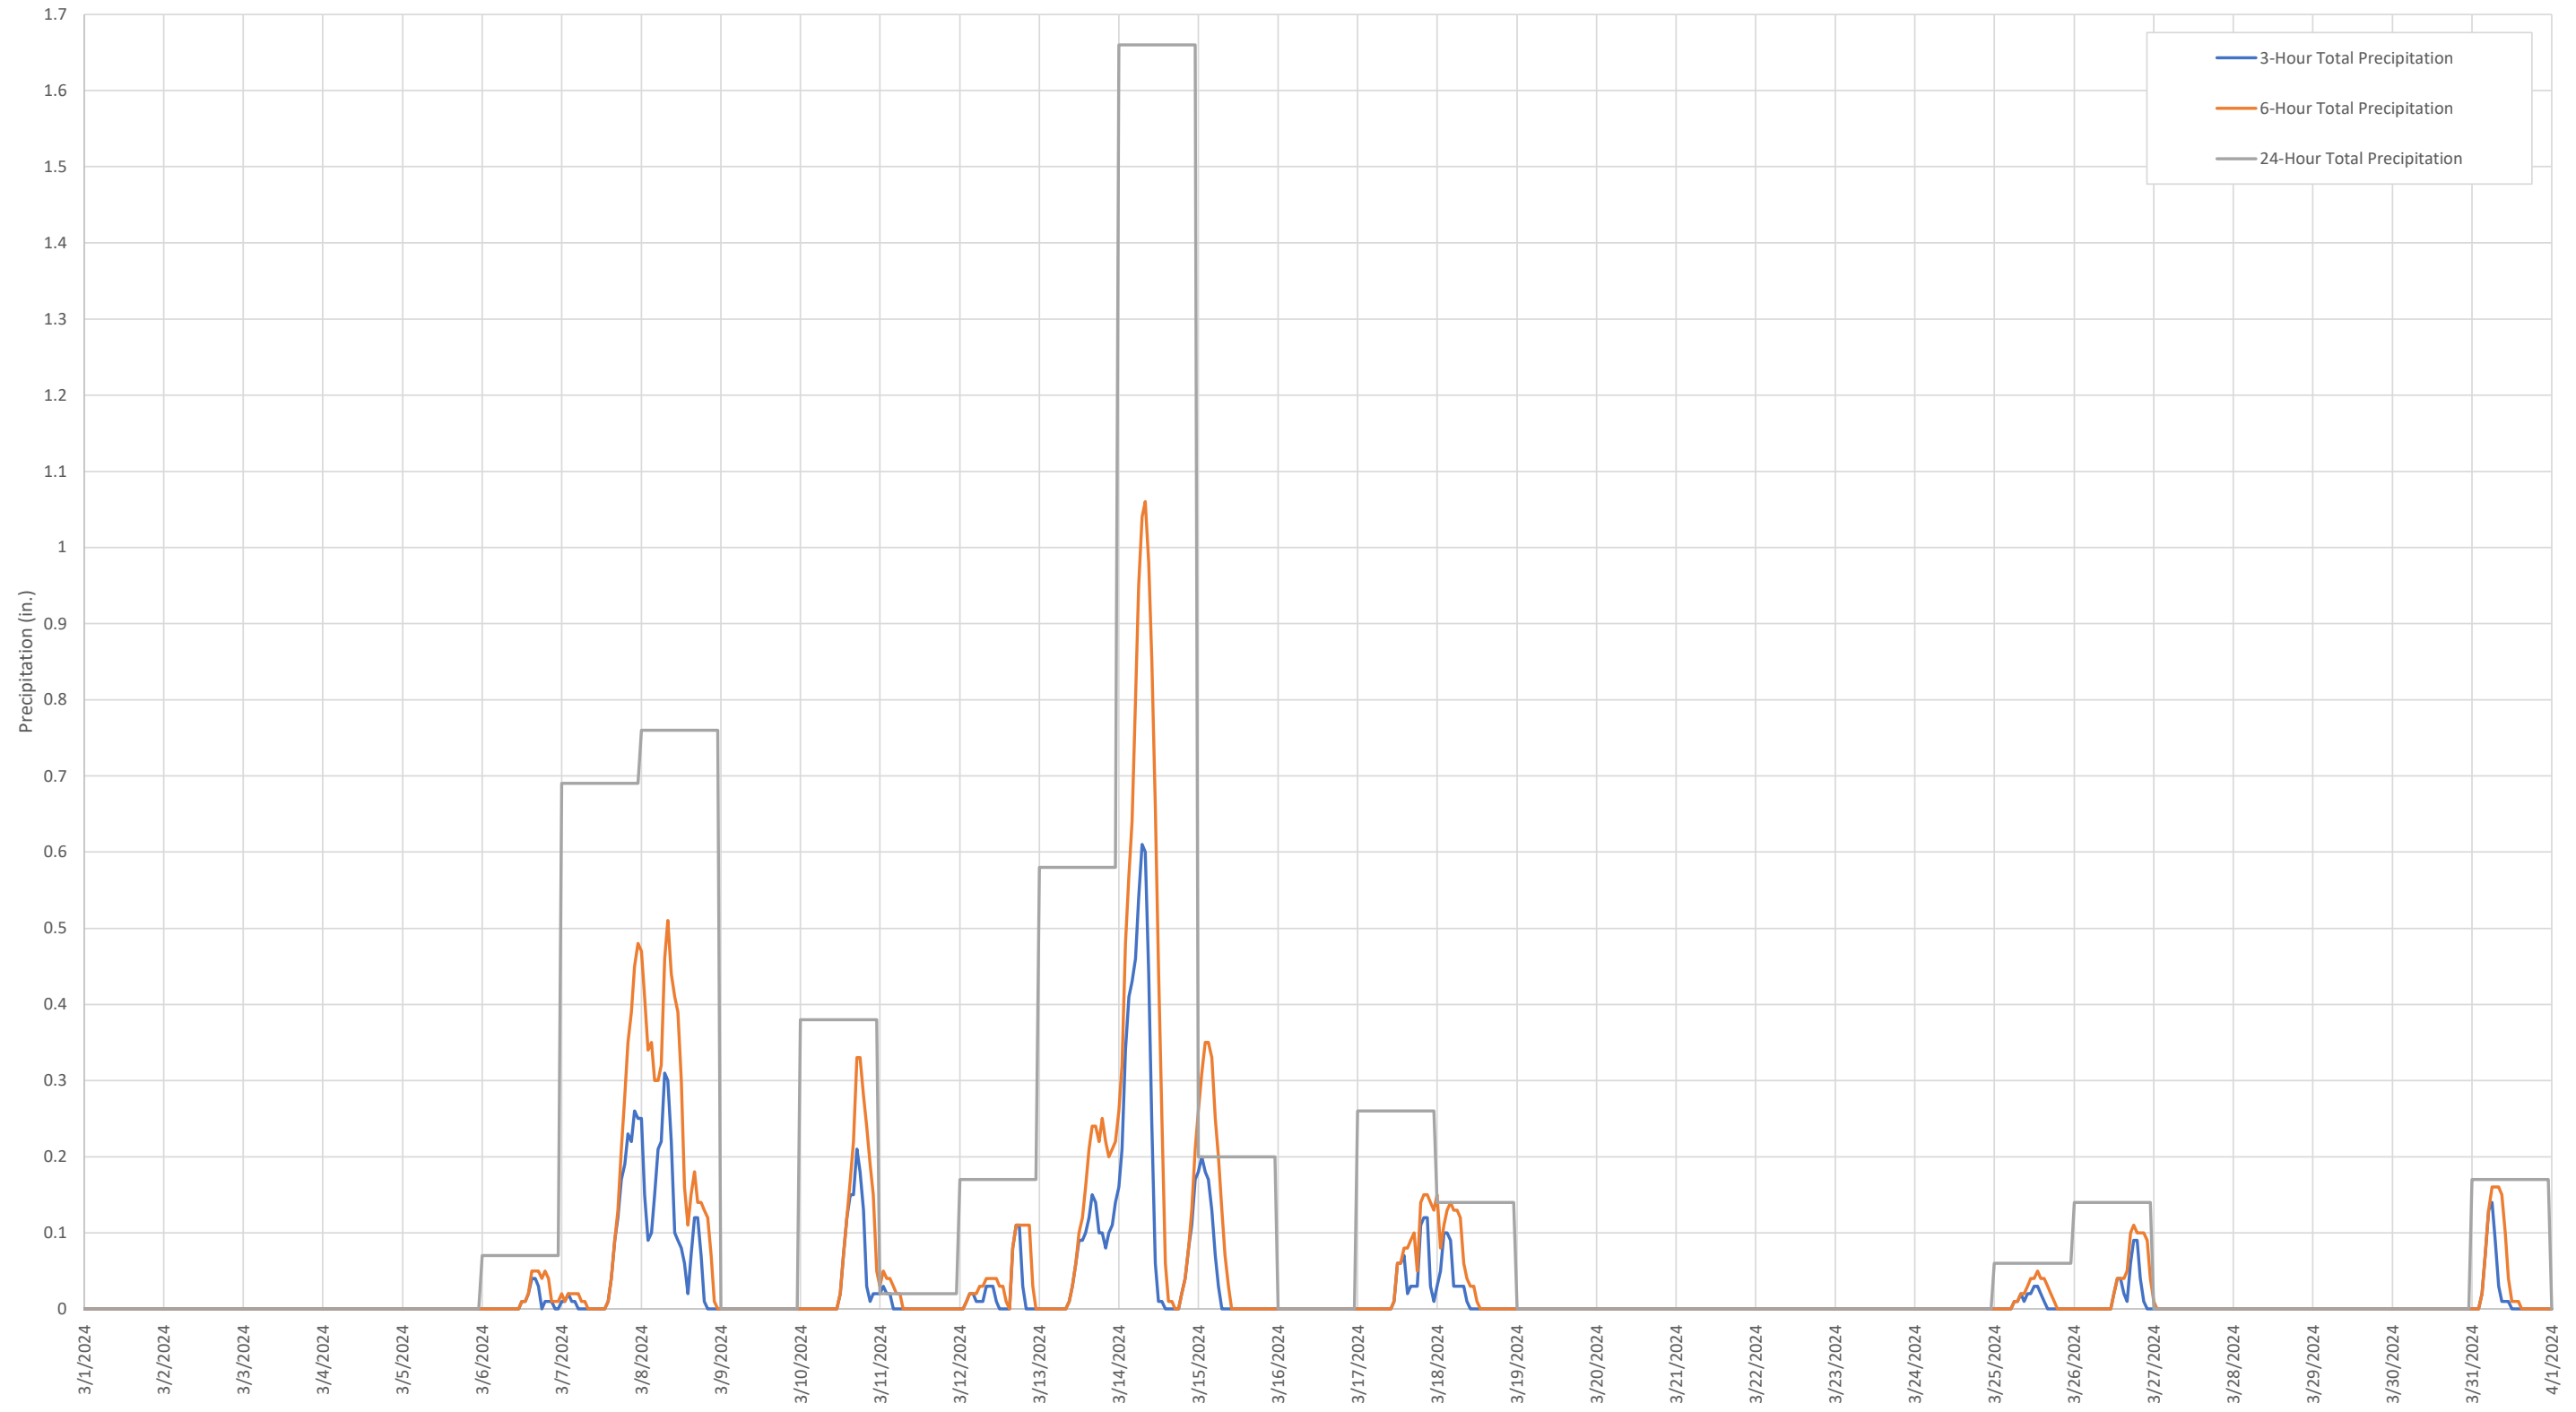
One significant weather event occurred during the March 2024 monitoring period. This weather event started on March 12, 2024 and ended on March 15, 2024. The peak of the storm occurred on March 14, 2024 with a maximum hourly rainfall rate of 0.21 inches per hour recorded at 0600H and 1.66 inches of precipitation recorded over 24 hours. The maximum 3-hour total precipitation during this storm was 0.61 inches. The storm caused erosion within the landslide path but did not impact Zimovia Highway.

Wrangell Zimovia Hwy MP 11.2 Landslide - Drone Dock Weather Station (WEMA2) Precipitation Data 03/01/2024 - 03/31/2024

Total precipitation measured at DOT&PF’s on-site weather station (Station ID WEMA2) for the month of March 2024 was 5.3 inches. Precipitation data from WEMA2 for the subject monitoring period is provided graphically in Appendix A. Precipitation data from November 17, 2023 through March 31, 2024 is also provided in Appendix A for reference.

Each figure in Appendix A provides 3-hour, 6-hour, and 24-hour total precipitation amounts. These total precipitation amounts are monitored because debris flow type landslide initiation is typically a function of soil saturation due to cumulative rainfall and the rainfall intensity immediately before landslide initiation. Table 2 below summarizes precipitation events with a 3-hour total precipitation amount greater than 0.3 inches during the subject monitoring period. Field observations during the initial landslide response and subsequent monitoring indicate that at least 0.3 inches of precipitation over a three-hour period is required to mobilize sufficient material from the landslide path for the material to collect in the highway ditch. The November 17, 2023 through November 20, 2023 precipitation data is provided for reference.

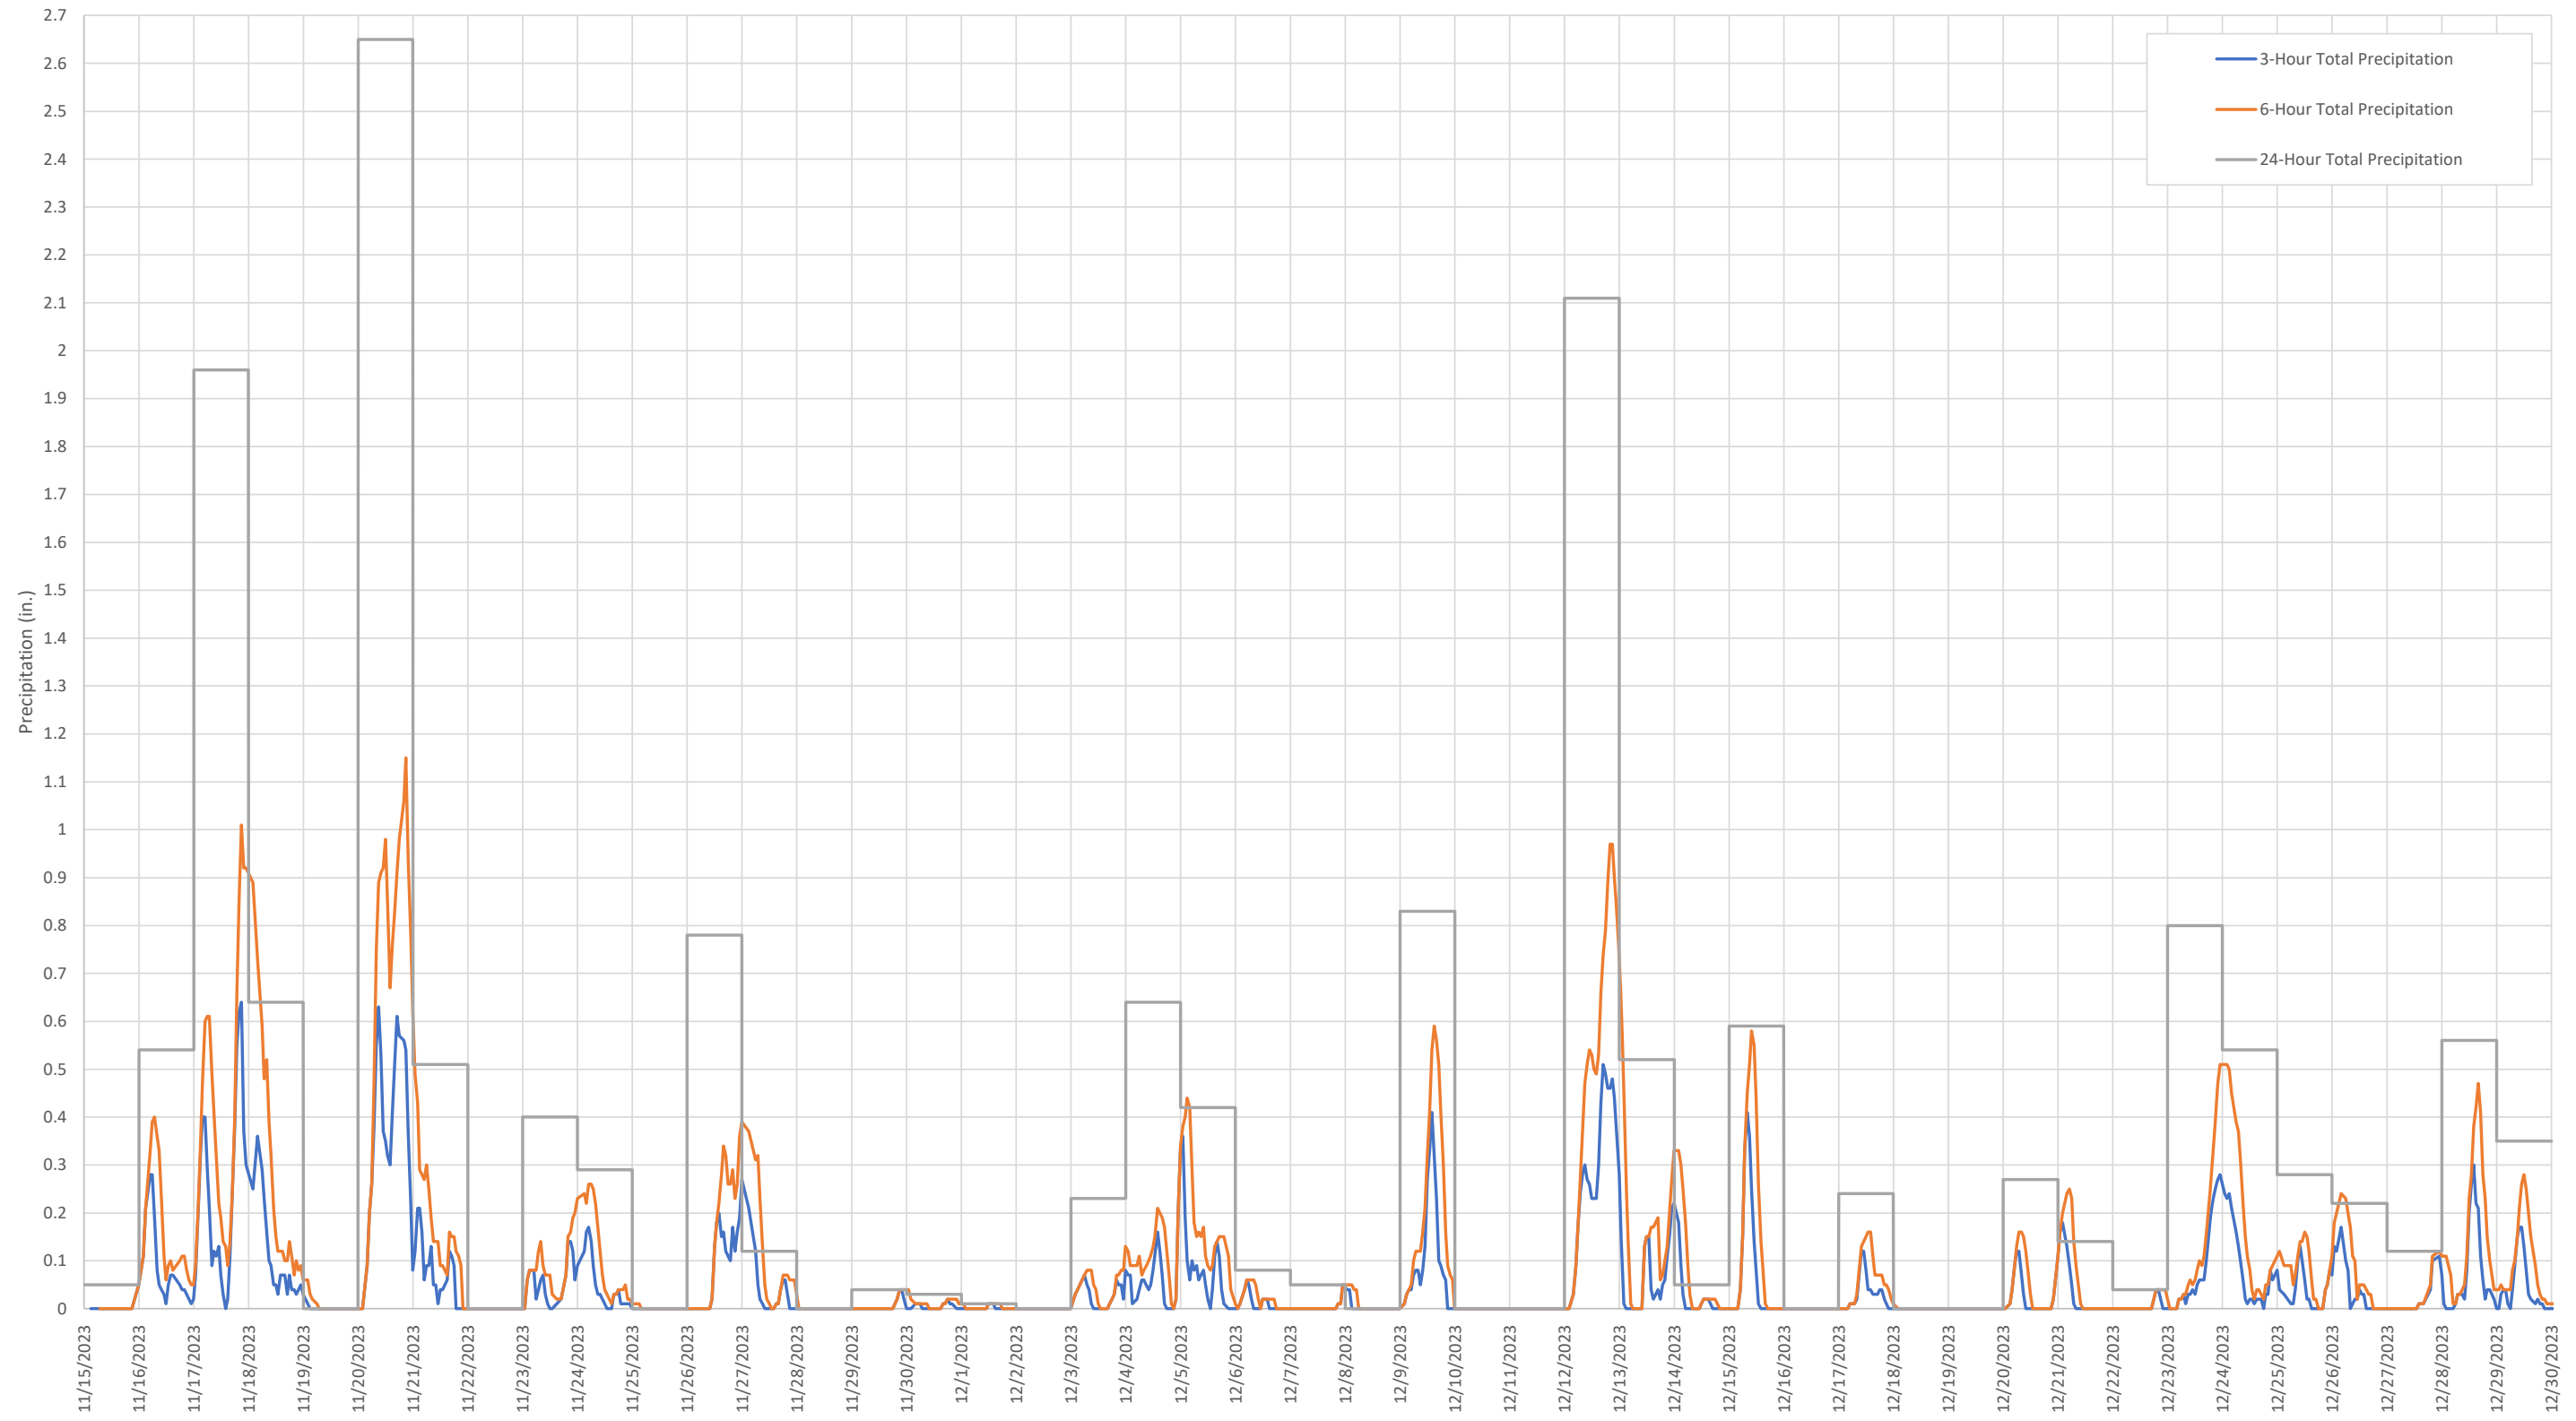
Wrangell Zimovia Hwy MP 11.2 Landslide - Airport Weather Station (PAWG) Precipitation Data 11/15/2023 - 12/31/2023

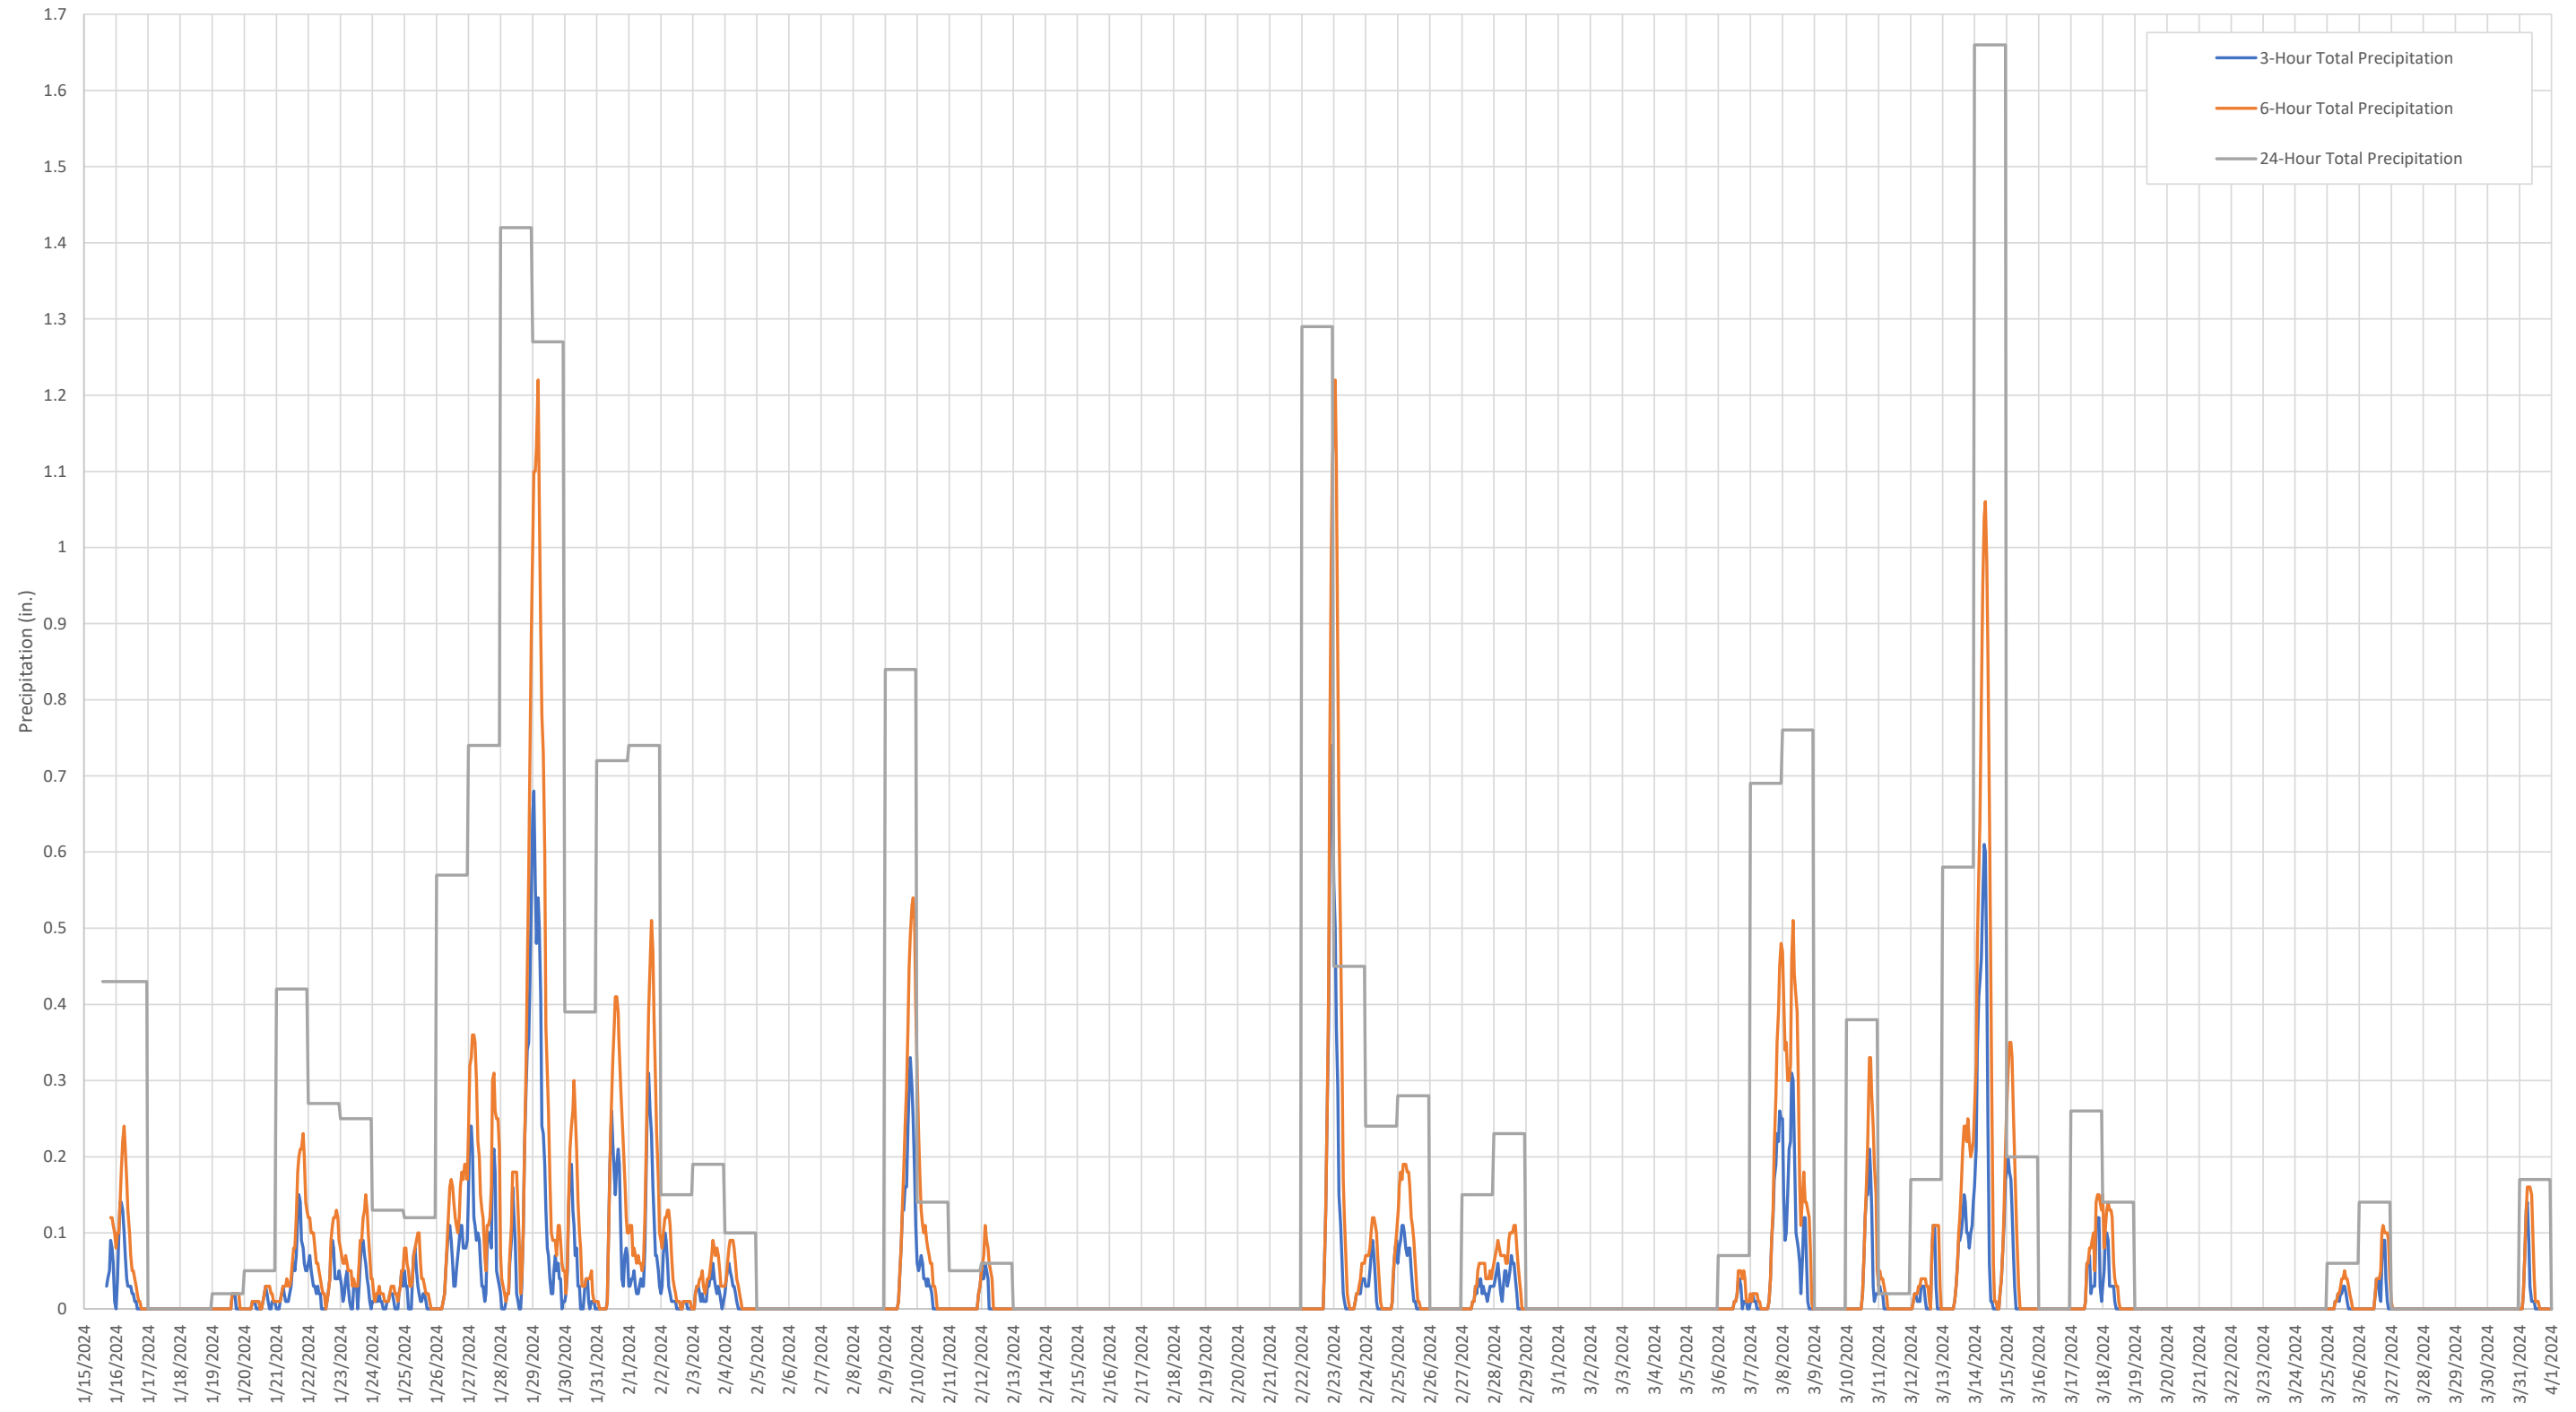
Wrangell Zimovia Hwy MP 11.2 Landslide - Drone Dock Weather Station (WEMA2) Precipitation Data 01/15/2024 - 03/31/2024
