CITY & BOROUGH OF WRANGELL

BOROUGH MANAGER'S REPORT

MEMORANDUM

SUBJECT: SDRER0561– WRG Zimovia
Highway Milepost 11.2 Landslide;
11/2023-02/2024 Monitoring
Summary

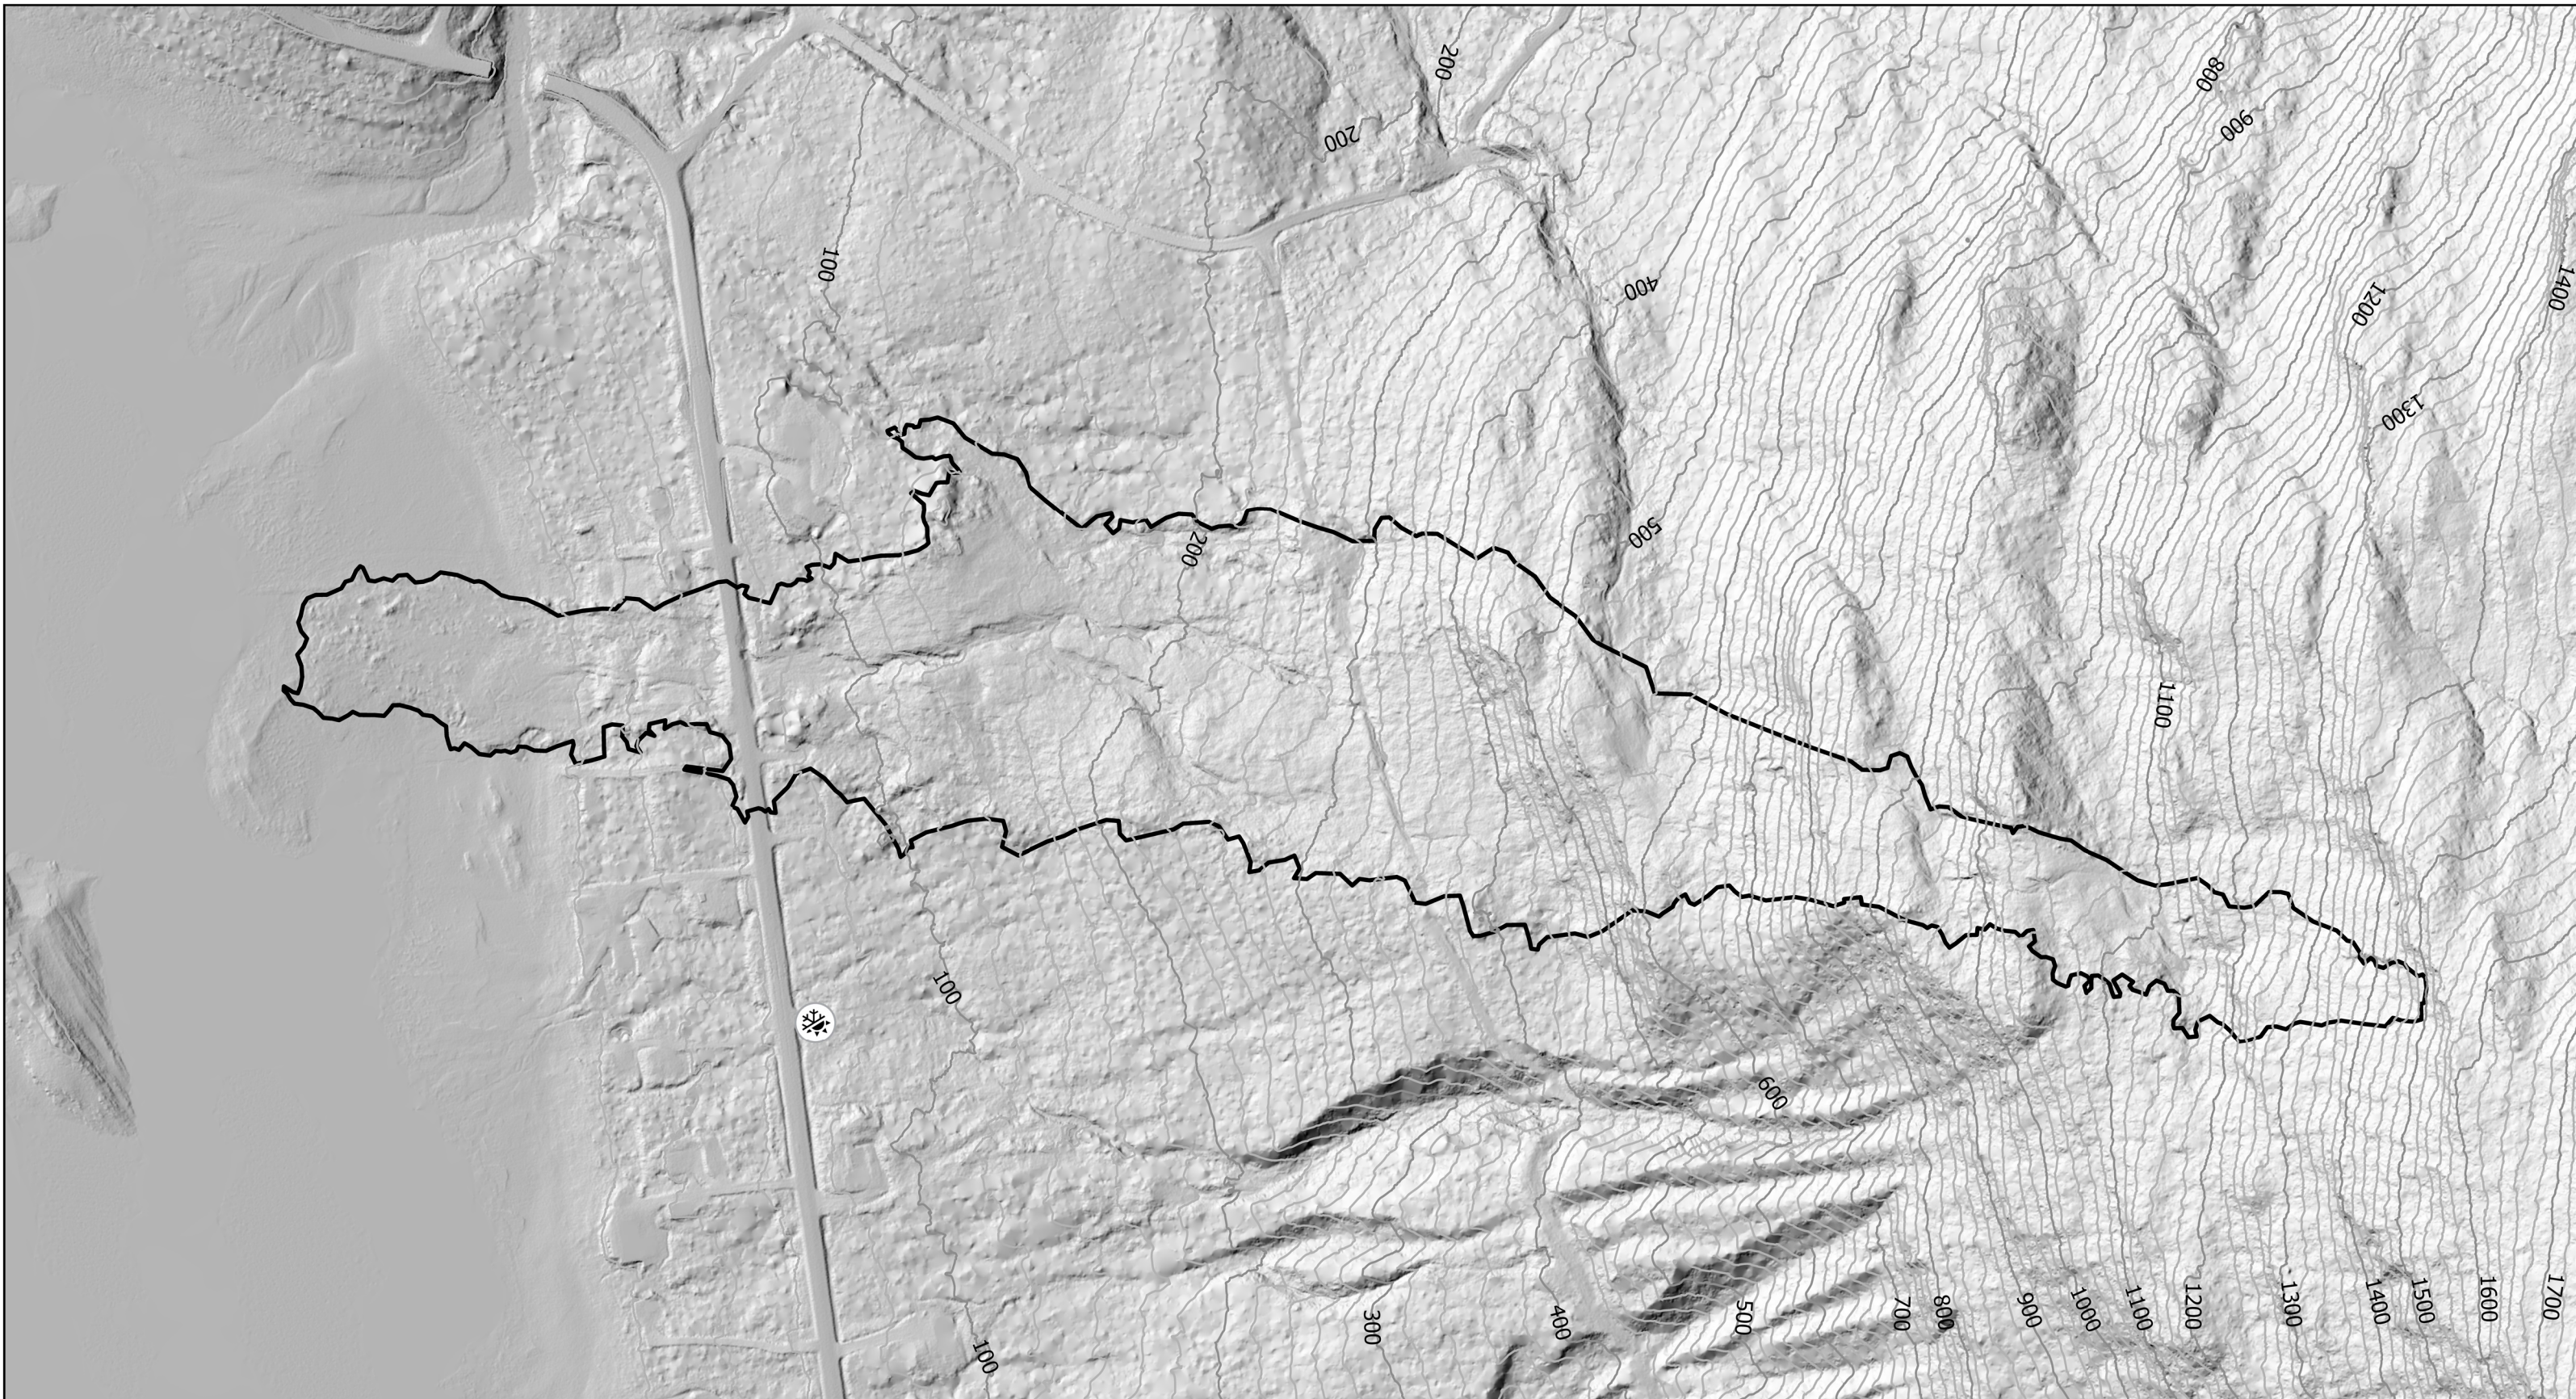
<p>State of Alaska Department of Transportation and Public Facilities Southcoast Region</p>
FIGURE 1

DOT&PF installed a remote UAS docking station and weather station at the landslide site on December 20, 2023. The monitoring equipment is located near the southern flank of the landslide toe at Latitude 56.337137, Longitude -132.339077. The location of the monitoring equipment is shown in attached Figure 1. Photographs of the monitoring equipment installation are provided in Appendix A. The remote UAS dock and associated aircraft was deemed fully operational on January 11, 2024 and the weather station was fully functional on January 15, 2024.

SITE MAP	
<i>Wrangell Zimovia Highway MP 11.2 Landslide</i>

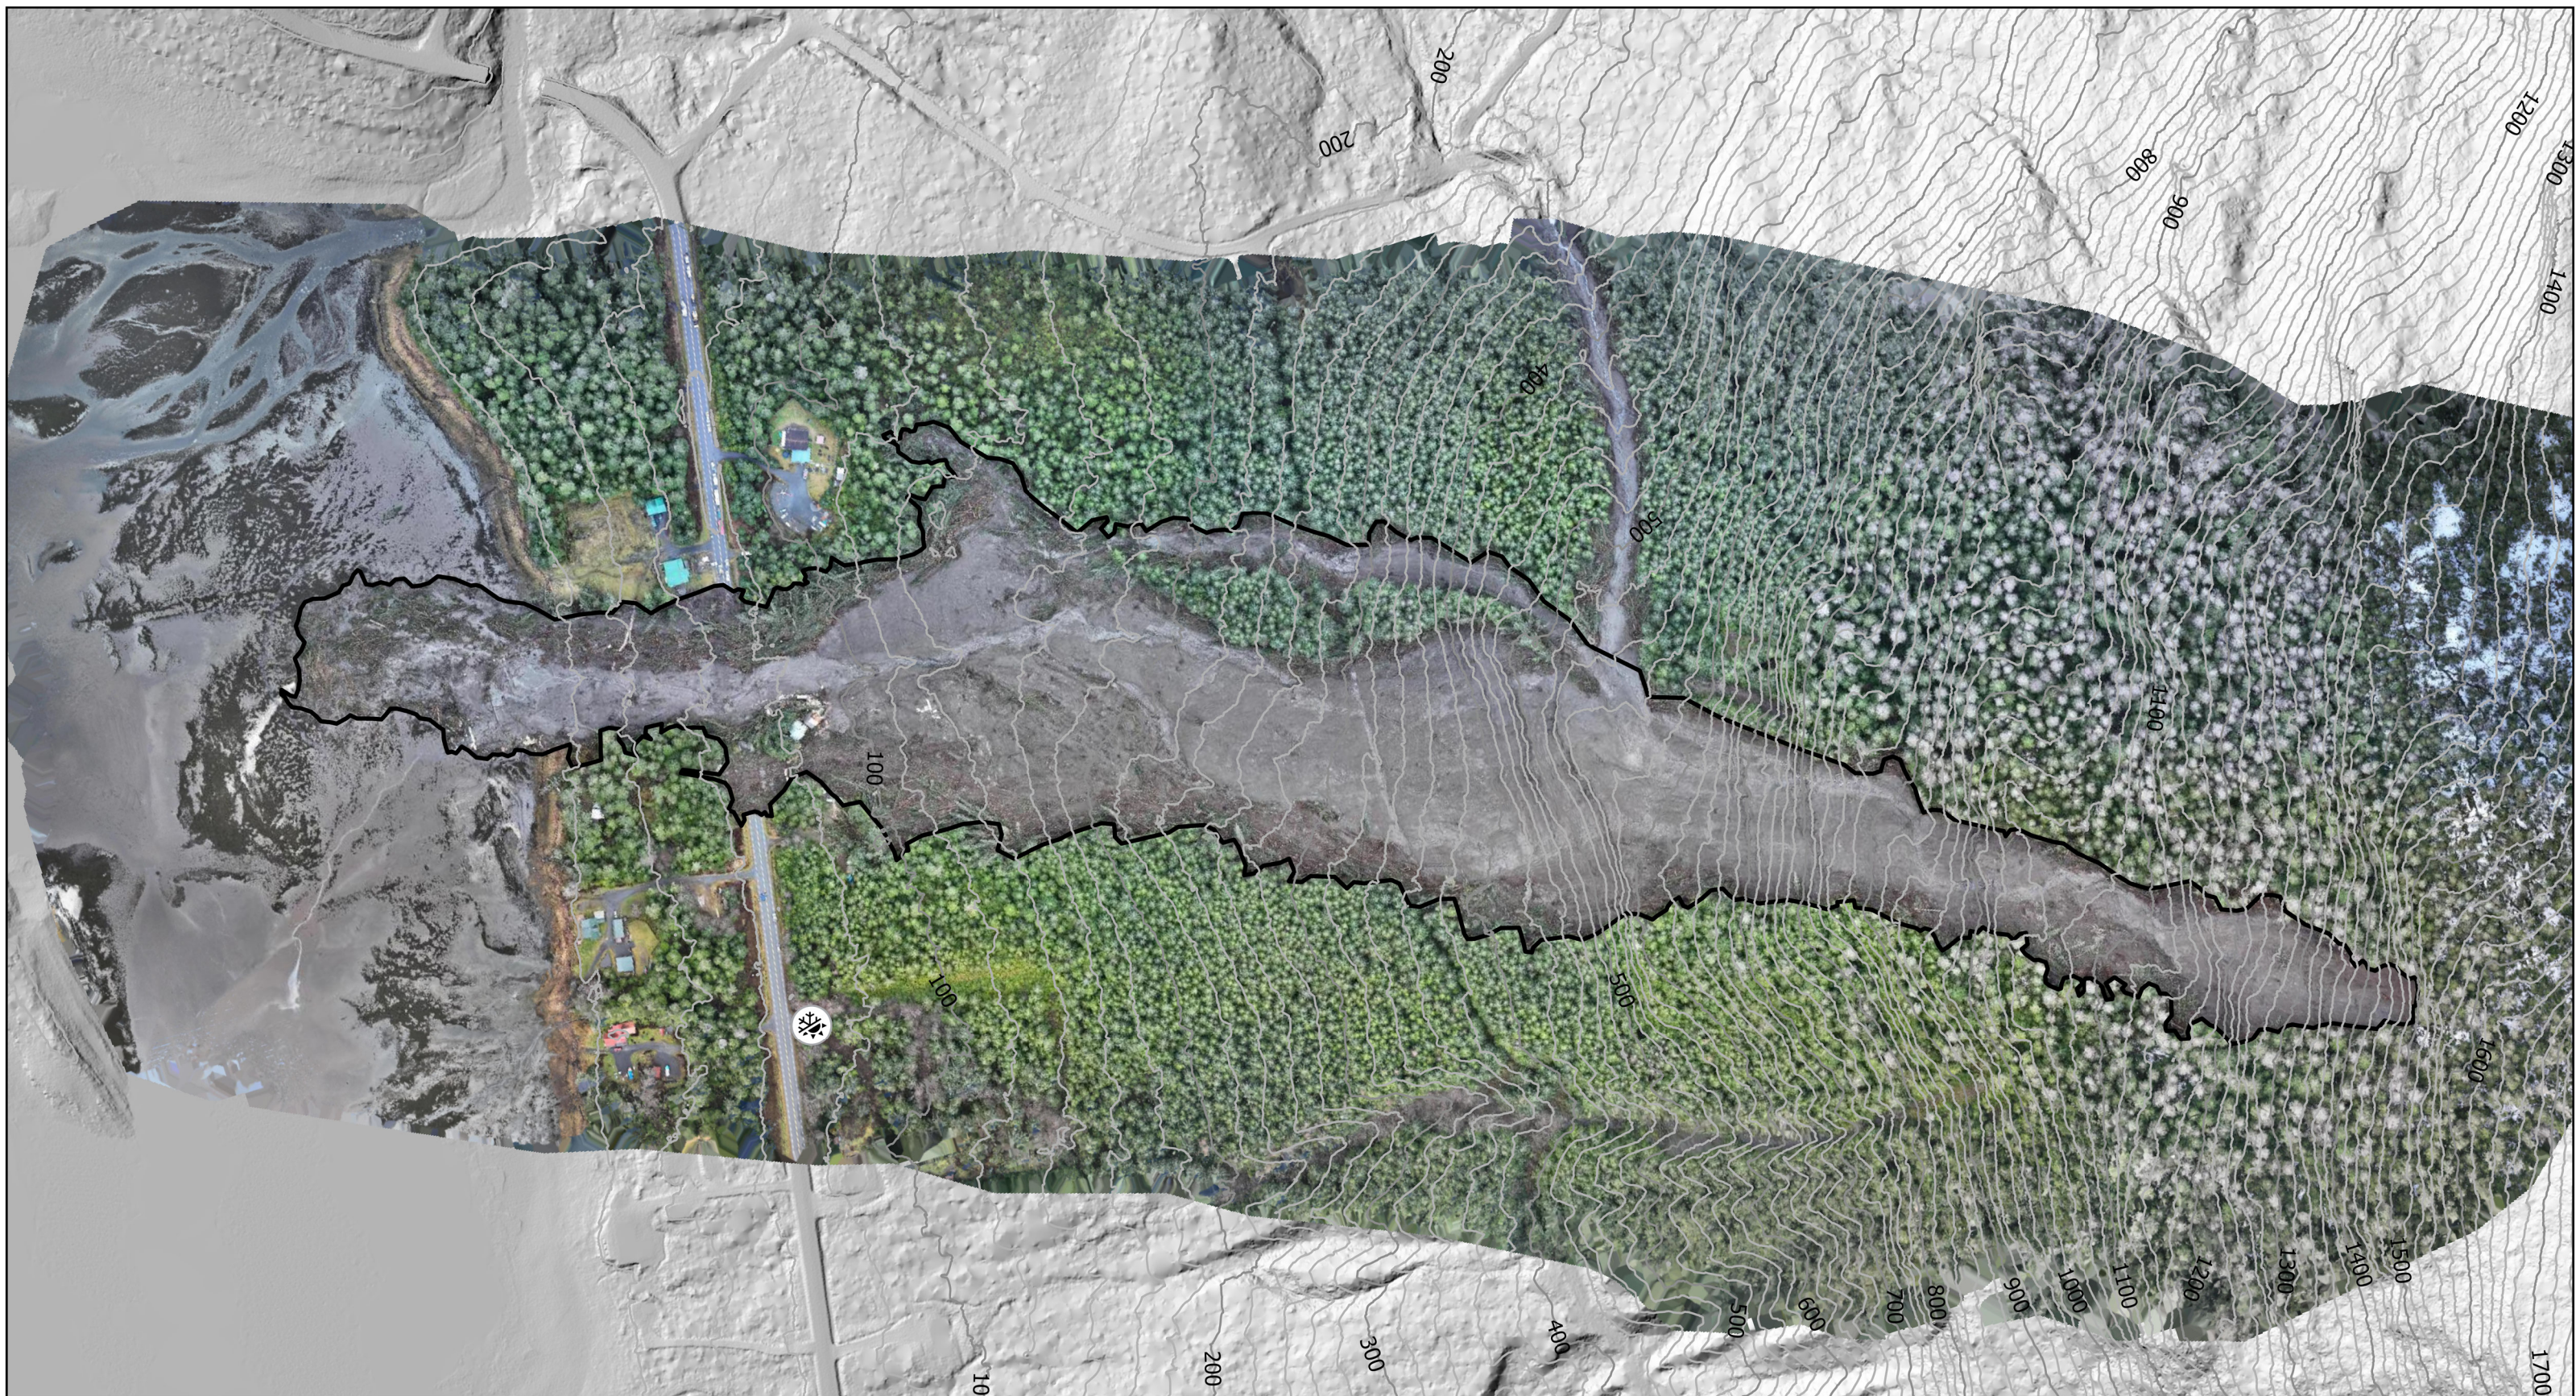
FIGURE 2

Table 2 lists orthoimagery mapping missions of the full landslide path successfully completed to date. Mapping missions were attempted on a weekly basis after the drone dock was installed but several missions in January 2024 were unsuccessful due to weather. Based on observations to date, the scheduled flight frequency will be reduced to one mapping mission per month or as needed based on precipitation events. Figure 2 shows the orthoimagery dataset collected on 11/22/2023. Figure 3 shows the latest orthoimagery dataset collected on 2/20/2024.

NOVEMBER 22, 2023 ORTHOIMAGERY

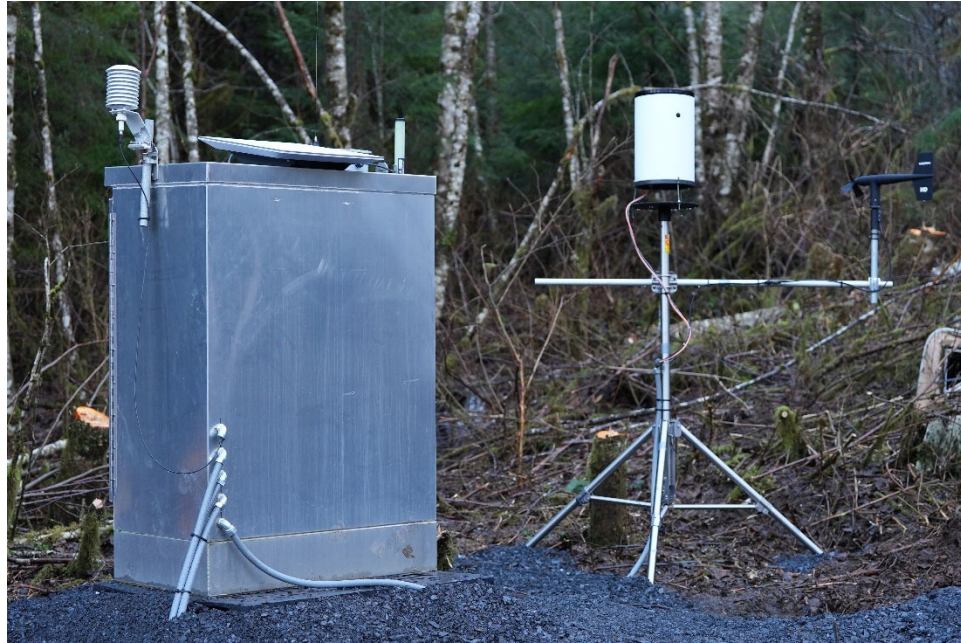
Table 1 provides a list of the equipment and instruments installed at the site. The UAS includes a drone, docking station, and avionics necessary for safety in remote operations. The weather station includes instruments for monitoring air temperature, relative humidity, wind speed, wind direction, and precipitation. The monitoring equipment is powered by a Wrangell Municipal Light and Power service connection and connected to the internet with a Starlink terminal.

Figure 1 - Avionics Cabinet and Weather Station WEMA2

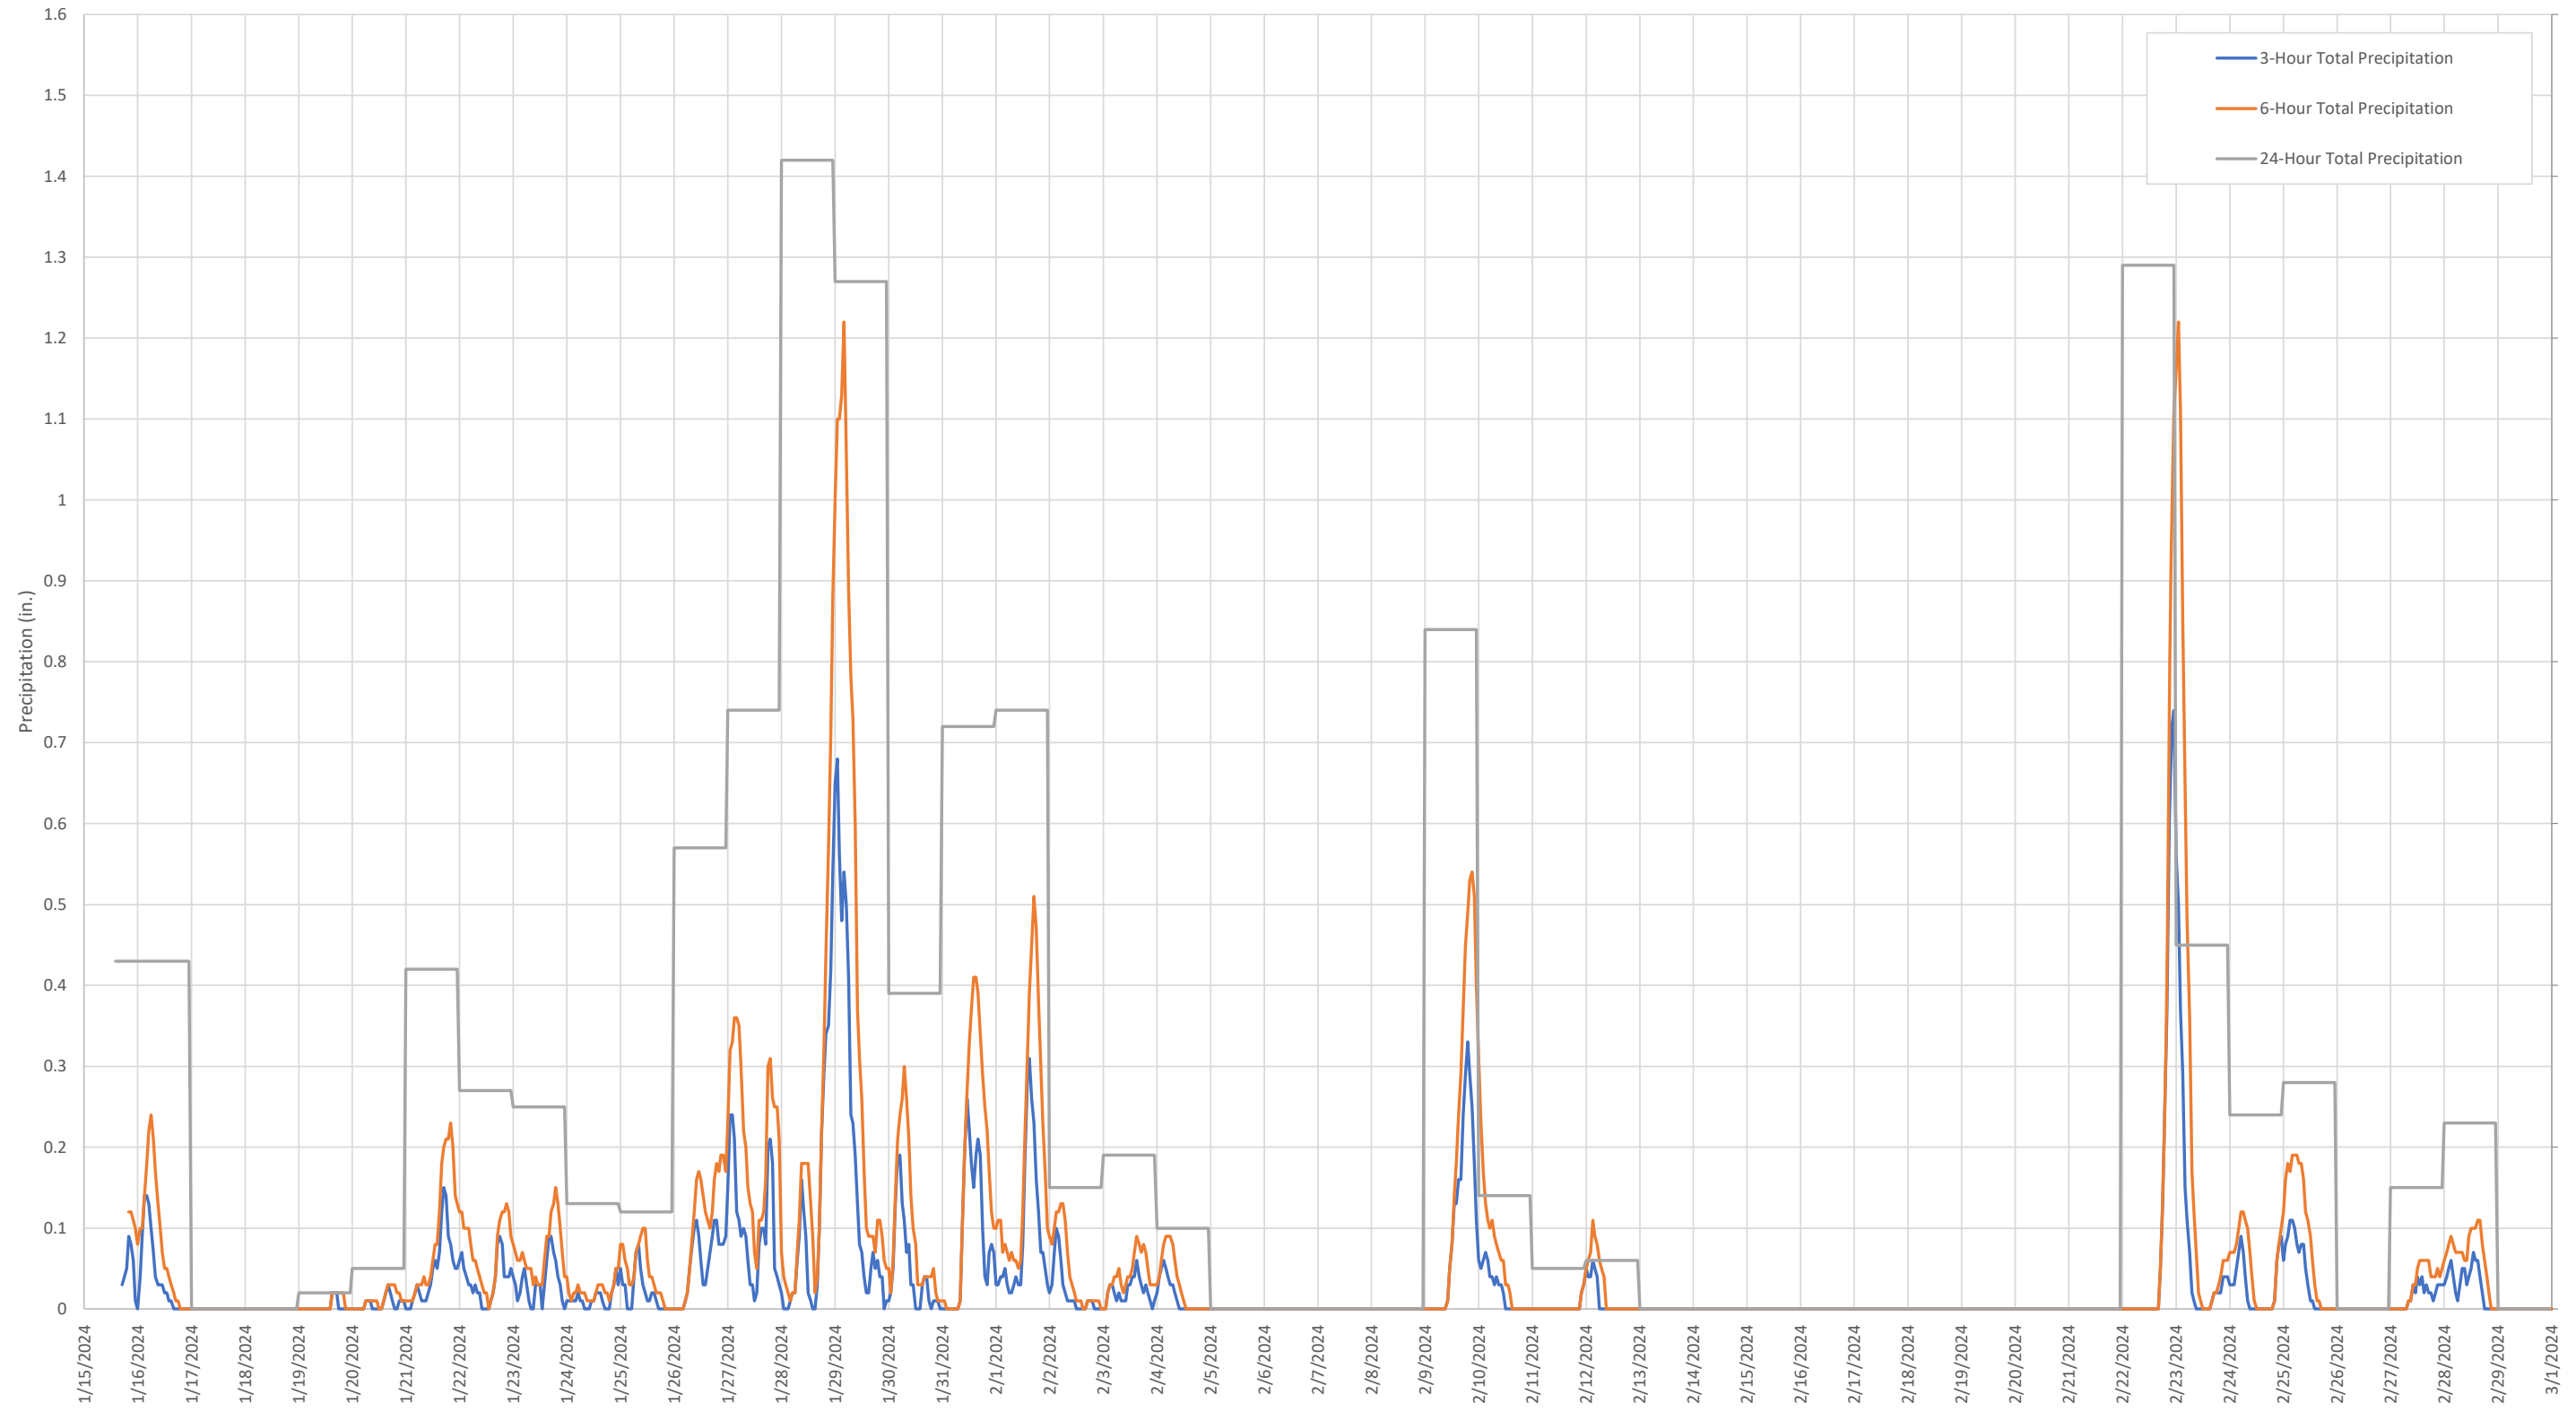
The second significant storm event started on January 26, 2024 and ended on February 2, 2024. This region wide eight-day storm event produced 6.0 inches of precipitation observed at WEMA2. The storm peaked on January 29, 2024 with 1.51 inches of precipitation in 24 hours. Multiple small landslides occurred throughout the region and in Wrangell on January 29, 2024. This storm resulted in significant erosion within the landslide path and downed trees along the MP 11.2 landslide margin.

The third significant storm event started rapidly on the evening of February 22, 2024 and ended 14 hours later on the morning of February 23, 2024 with 1.65 inches of precipitation observed at WEMA2. A maximum hourly rainfall rate of 0.31 inches was recorded at 2100H on February 22, 2024. Precipitation resumed on the evening of February 23, 2024. Drone observations of the impacts from this storm have not been possible due to continued poor weather as of the writing of this memo.

Wrangell Zimovia Hwy MP 11.2 Landslide - Drone Dock Weather Station (WEMA2) Precipitation Data 01/15/2024 - 02/29/2024
