RE: Wrangell Medical Center

Subj: Limited Asbestos Survey

This letter summarizes the findings associated with the limited asbestos survey conducted by Environmental Management, Inc. (EMI) in the Wrangell Medical Center (WMC), 310 Bennett Street, Wrangell, Alaska. The survey was performed on May 22 and 23, 2018, by Andy Coulson, an accredited Building Inspectors certified in accordance with the Asbestos Hazard Emergency Response Act (AHERA).

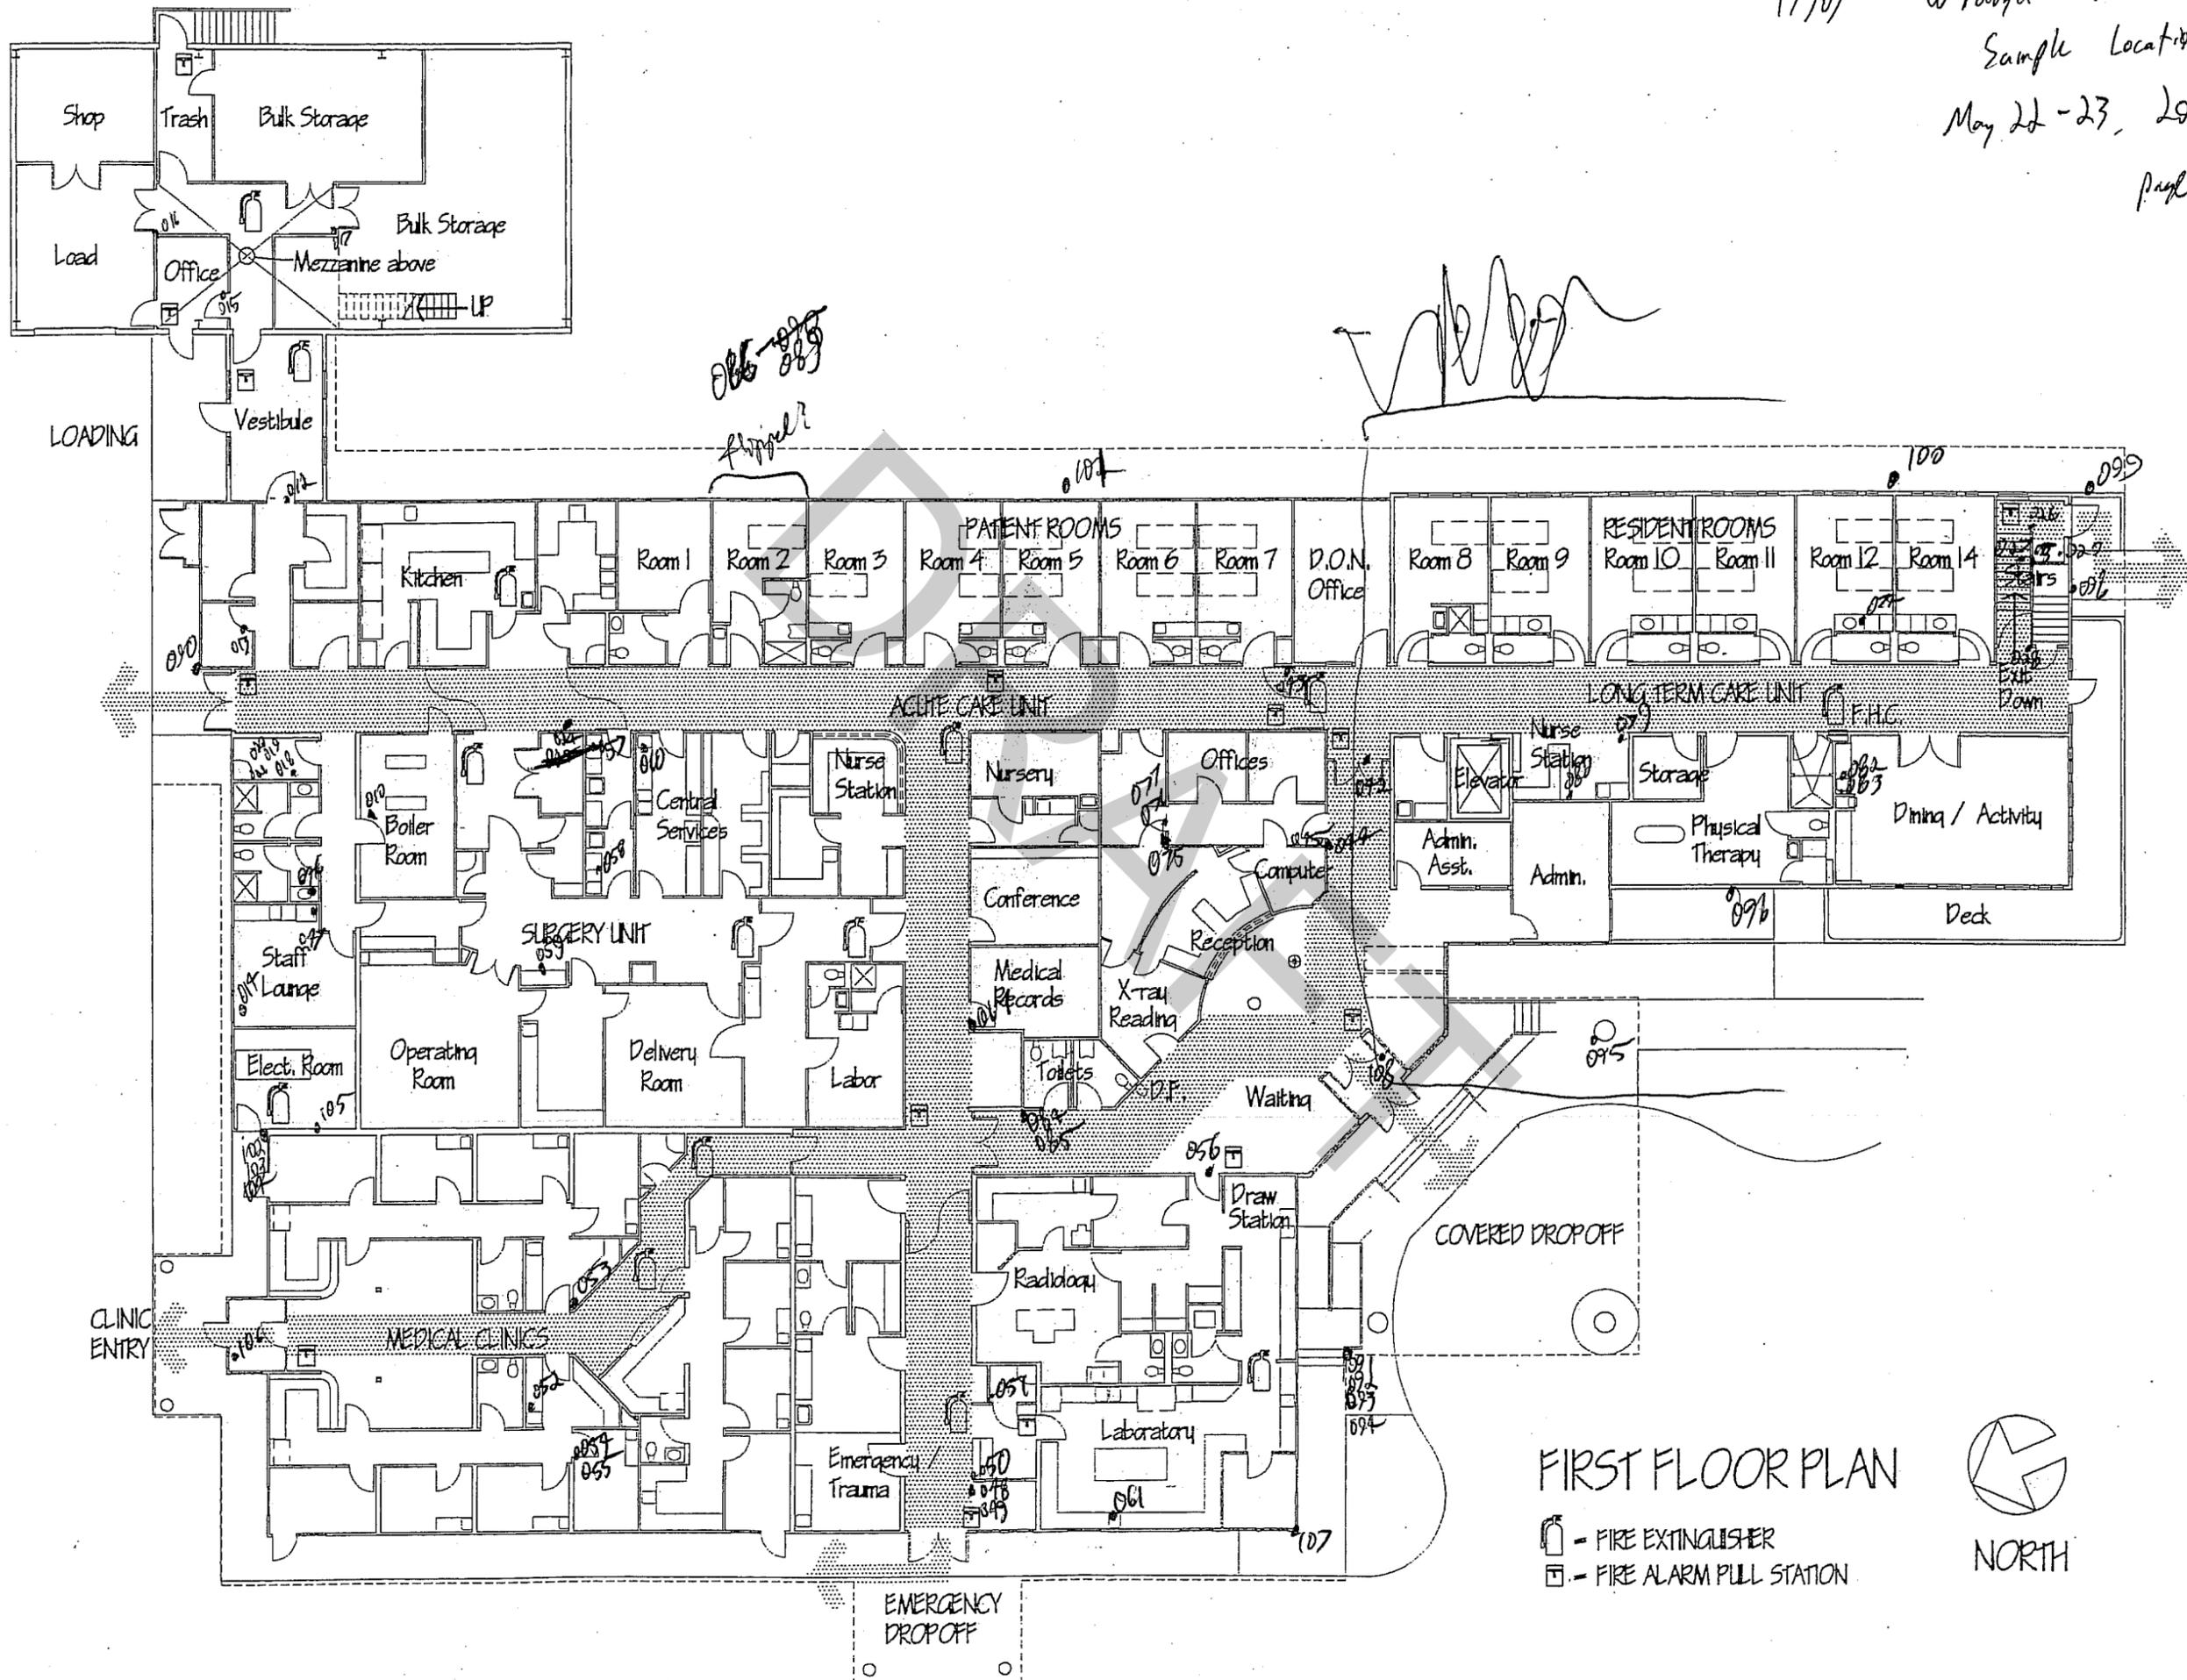
17909 W Poyell Medical Center
 Sample Locations
 May 22-23, 2018
 page 1

FIRST FLOOR PLAN

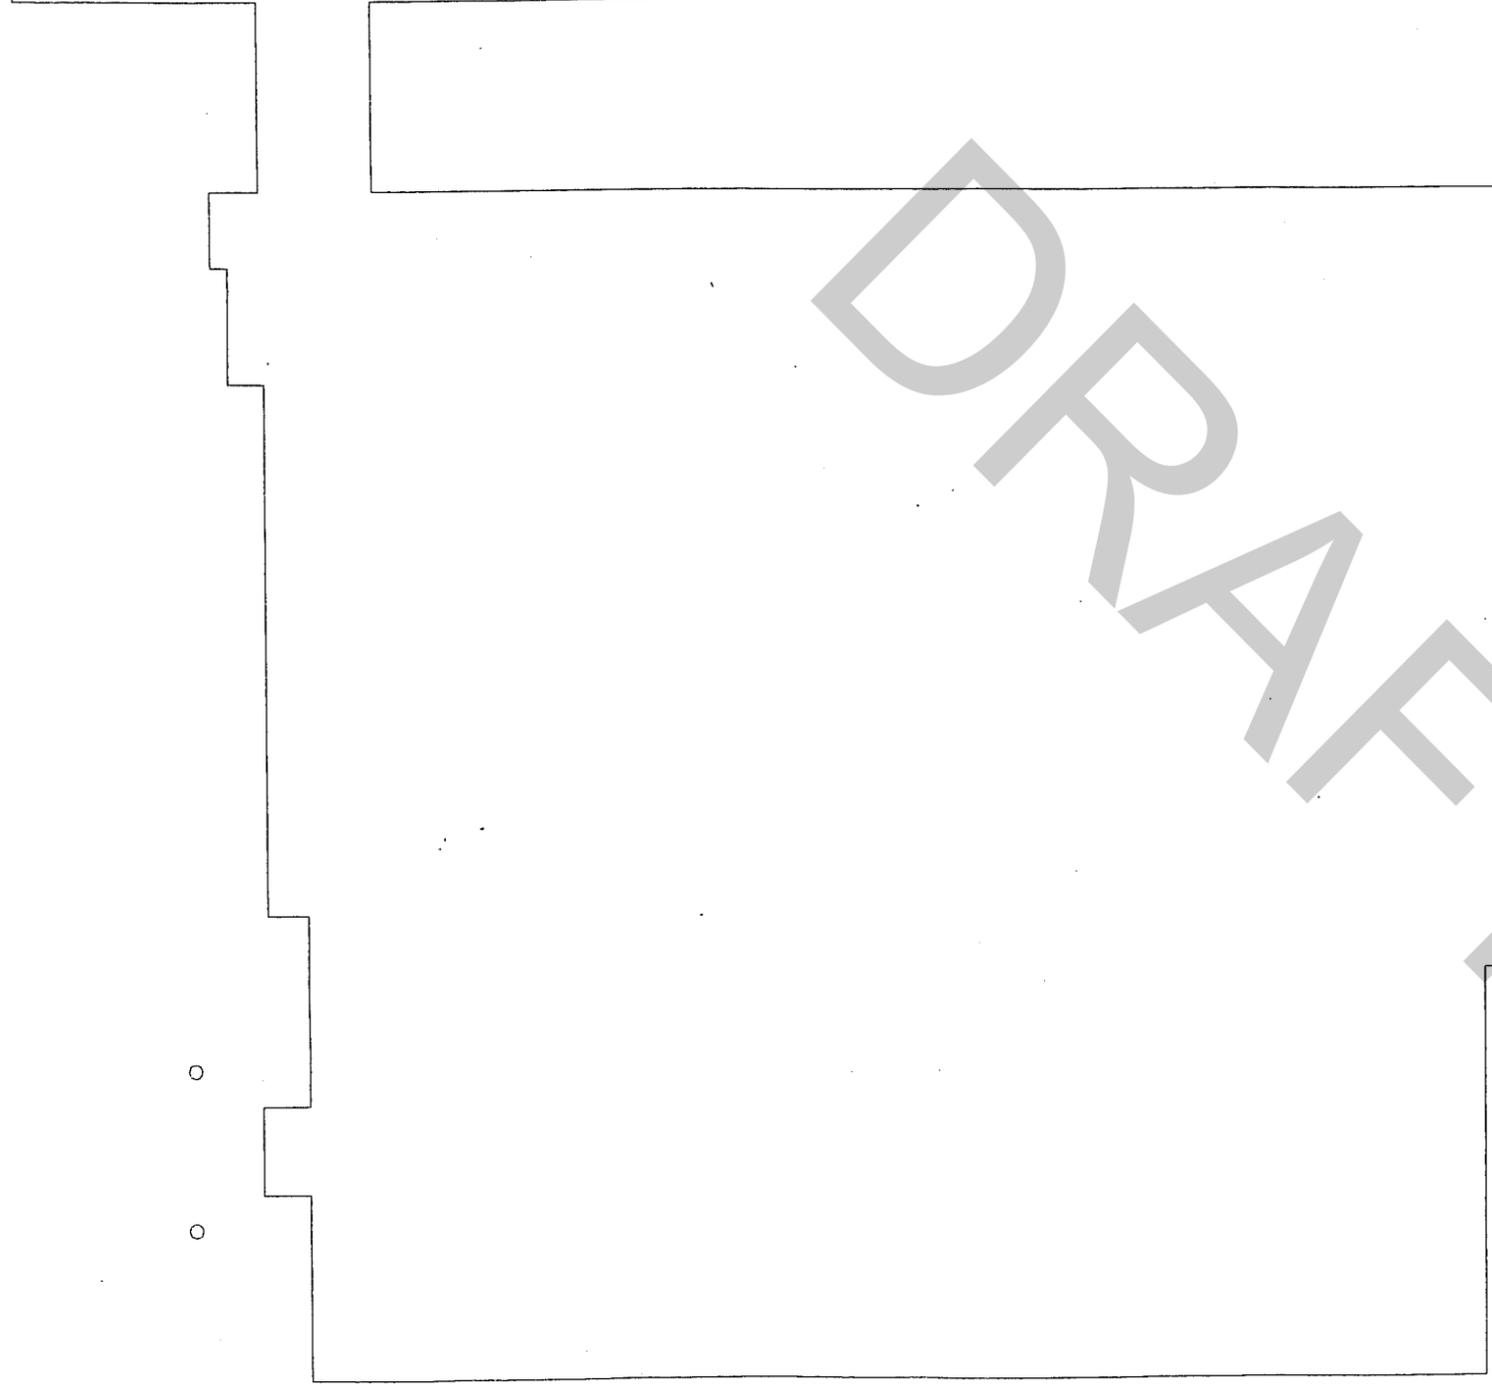
17909 Wrayell Medical Center
Sample Locations
May 22-23, 2018
page 2

BASEMENT FLOOR PLAN

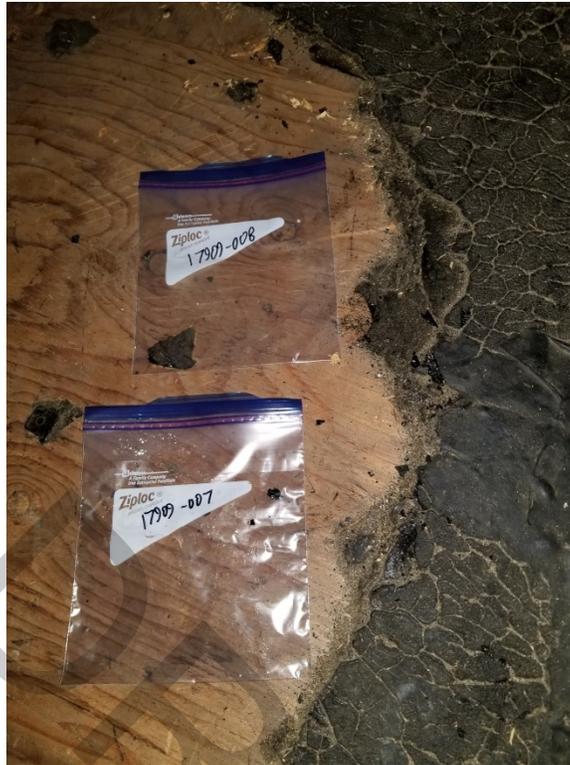
- The roofing material of the original Wrangell Health Center Building (samples 17909-007, 17909-062, 17909-063, 17909-064; photo 1).
- The tar paper skirts around HVAC penetrations in the attic of the new, modular addition to the building (sample 17909-066, photo 2).
- Grey sealant on one of the ducts in the air handler room (sample 17909-003, photo 3). Other ducts were covered in orange insulation, if grey sealant is encountered on them it should be considered ACM.
- A pale green caulk from the interior of the window of patient room 2 (sample 17909-088); other pale green window caulks should also be considered ACM.

Photo 1: Roofing material of the original building roof is ACM. (May 22, 2018)

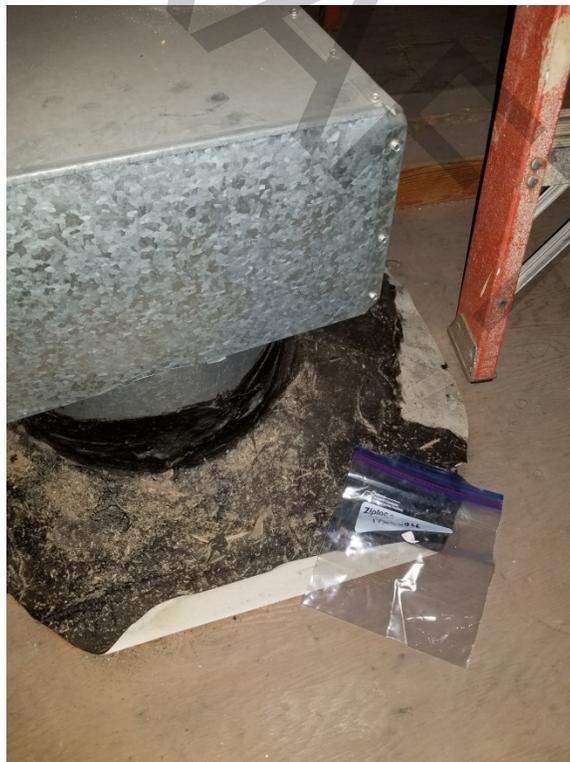
Photo 2: Tar paper skirts around penetrations in the new portion of the attic are ACM. (May 23, 2018)

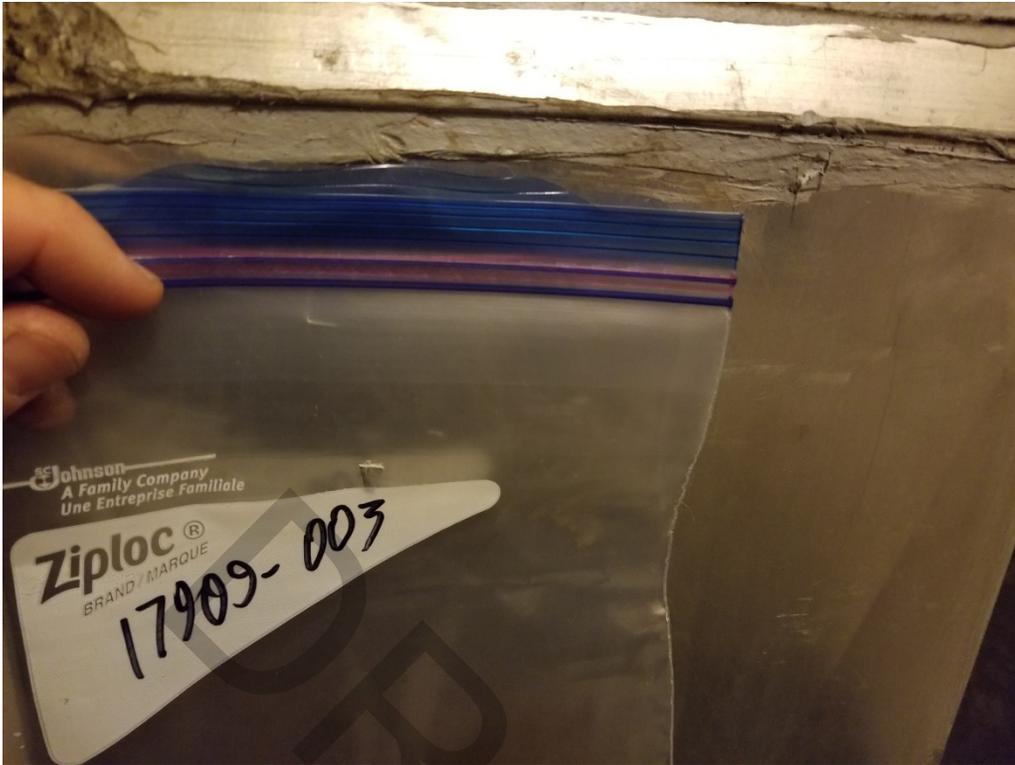
Photo 3: Grey duct sealant is ACM. (May 22, 2018)

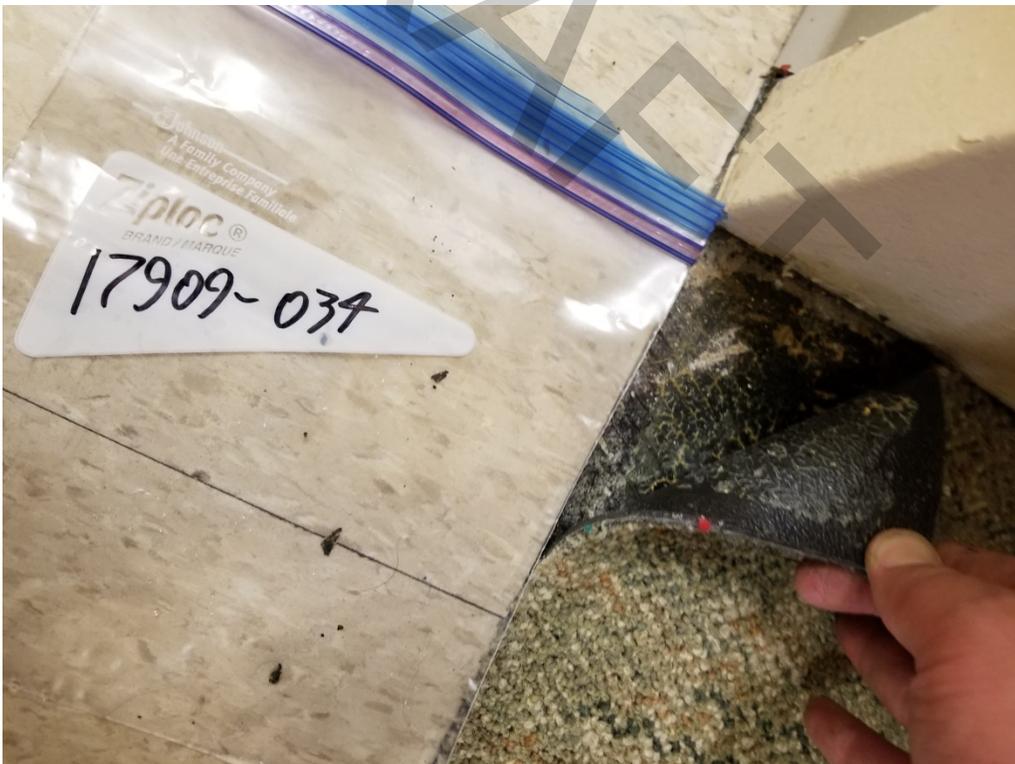
- Black mastic was observed in several locations beneath floor tiles and beneath the green carpet in the basement; it is represented in several samples (17909-028, 17909-029, 17909-034, 17909-037, 17909-042; photo 4). It was not observed outside of the residential care addition, but if black mastic is encountered elsewhere in the building it should be considered ACM.

Photo 4: Black mastic beneath found beneath floor tiles and green carpet in the basement. (May 22, 2018)

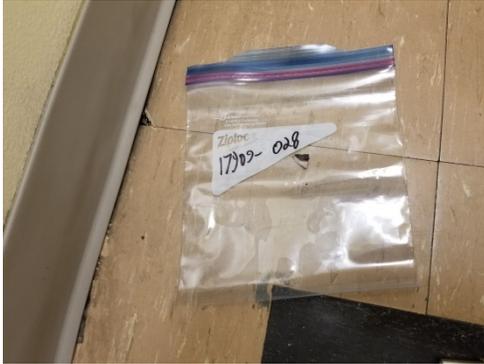
- Six different patterns of floor tiles were observed; three of which contained asbestos (17909-028, 17909-029, 17909-037; photos 5-7). Non-ACM floor tiles (Photos 8-10) may still be associated with the black mastic described above (For example, sample 17909-042). Because the colors and patterns of ACM and Non-ACM floor tiles are similar, and the differences do not show up well in photographs, all floor tiles should be considered ACM unless verified with specific samples to show they are not ACM.

Photo 5: Pink floor tiles in the upper landing of the stairway were ACM, and had a black ACM mastic. Tile appears beige in this photograph; appeared pink when sampled. (May 22, 2018)

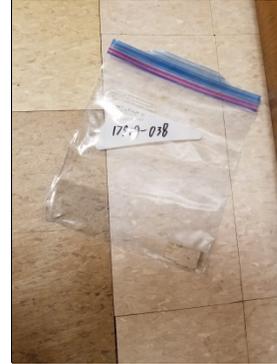
Photo 8: Asbestos was not detected in white floor tiles in the basement storage room, and no black or ACM mastics were detected. (May 22, 2018)

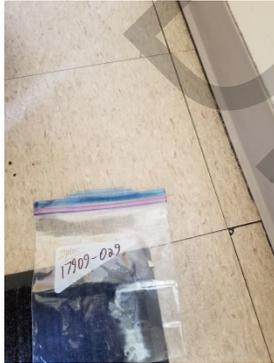
Photo 6: Off-white floor tiles in the stairway were ACM, and had a black mastic with trace amounts of asbestos. (May 22, 2018)

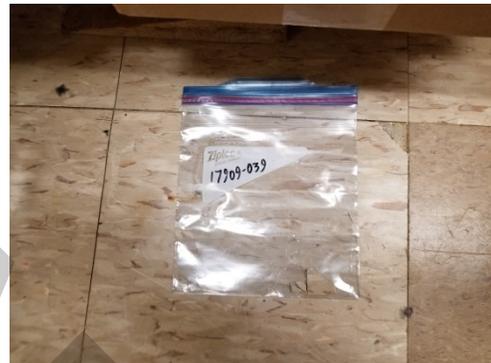
Photo 9: Asbestos was not detected in speckled beige floor tiles in the basement storage room, and no black or ACM mastics were detected. (May 22, 2018)

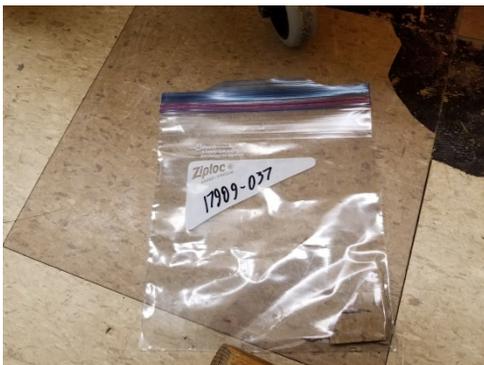
Photo 7: Brown floor tiles in the basement storage room were ACM, and had a black ACM mastic. (May 22, 2018)

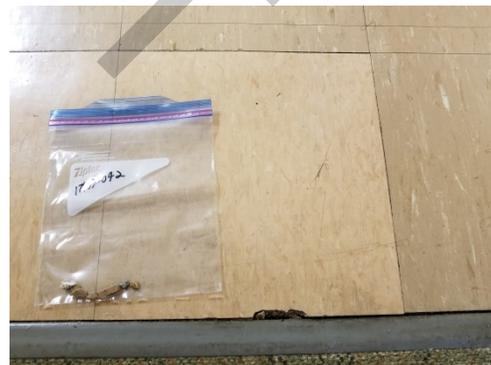
Photo 10: Asbestos was not detected in pink floor tiles in the entrance to the long term care wing, but tiles did have a black ACM mastic. Tile appears grey in photograph, but appeared pink when sampled. (May 22, 2018)

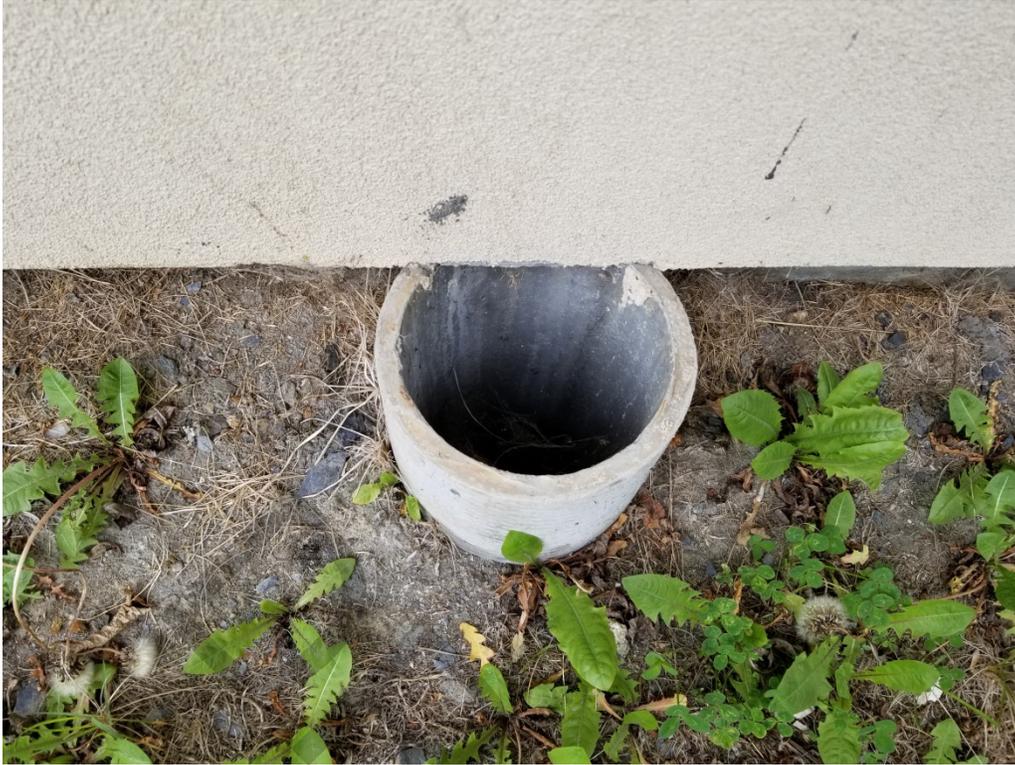
- A single cement standpipe was observed on the east side exterior of the building near the southeast corner. This cement contained asbestos (sample 17909-100, photo 11).

Photo 11: The cement standpipe near the southeast corner of the building is ACM. (May 23, 2018)

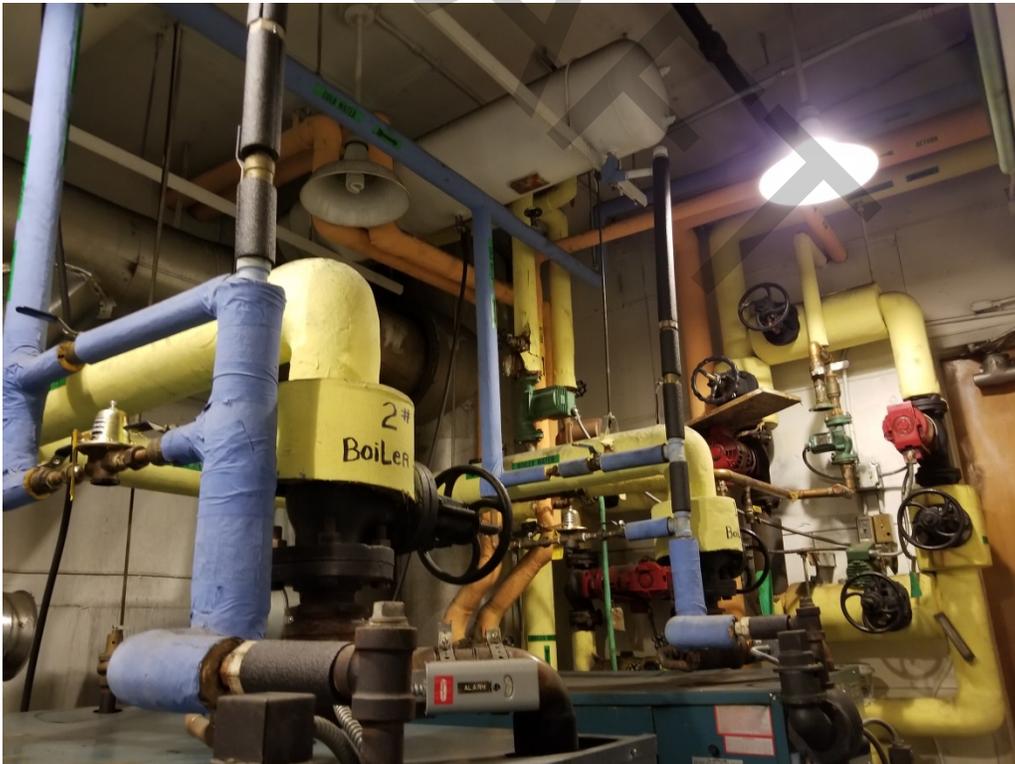
In addition to the sampled materials, Thermal System Insulation that is presumed to contain asbestos was observed in the boiler room (Photo 12), air handler room (Photo 13), and in the attic below the old roof (Photo 14). This material consisted of a presumed ACM pipe wrapping as well as a presumed ACM hard insulating material at joints and valves. Some limited sections of the ACM pipe wrapping appear to have been replaced with fiberglass. This material is in fair condition, with a couple nicks in the encapsulating wrap around the TSI, and in several locations the ends of hard insulating pipe joints are exposed (Photo 15). Due to the heterogeneous nature of these TSI materials, they were not sampled. If the TSI is not fiberglass it must be presumed to be ACM. No suspect TSI was observed in the crawlspaces or in the two newer sections of the building.

Because of the building's age several materials should be assumed to be ACM. The metal flue from the boilers in the boiler room should be assumed to contain ACM insulating material. Fire-rated doors, including 2 attic access hatches, should be assumed to contain asbestos. Several flanged pipe joints were observed in the boiler room, these should be assumed to contain an ACM gasket. Elevator brake pads, internal components of boilers, furnaces, and other pieces of building mechanical equipment often contain asbestos and need to be handled accordingly. To avoid damaging the roof, any tar paper, vapor barrier, or other roofing materials under the metal roof were not sampled and should be assumed to possibly be ACM. Flexible duct joints were in good condition and observed to be labeled as Ventglas, which as currently produced is a non-ACM fiberglass product; however, because it is unknown what the composition was when these joints were installed, these and other flexible duct joints should be assumed to be ACM unless further information is obtained to show otherwise.

Photo 12: Presumed ACM TSI in the boiler room. Flue in back corner is assumed to contain ACM insulation. (May 22, 2018)

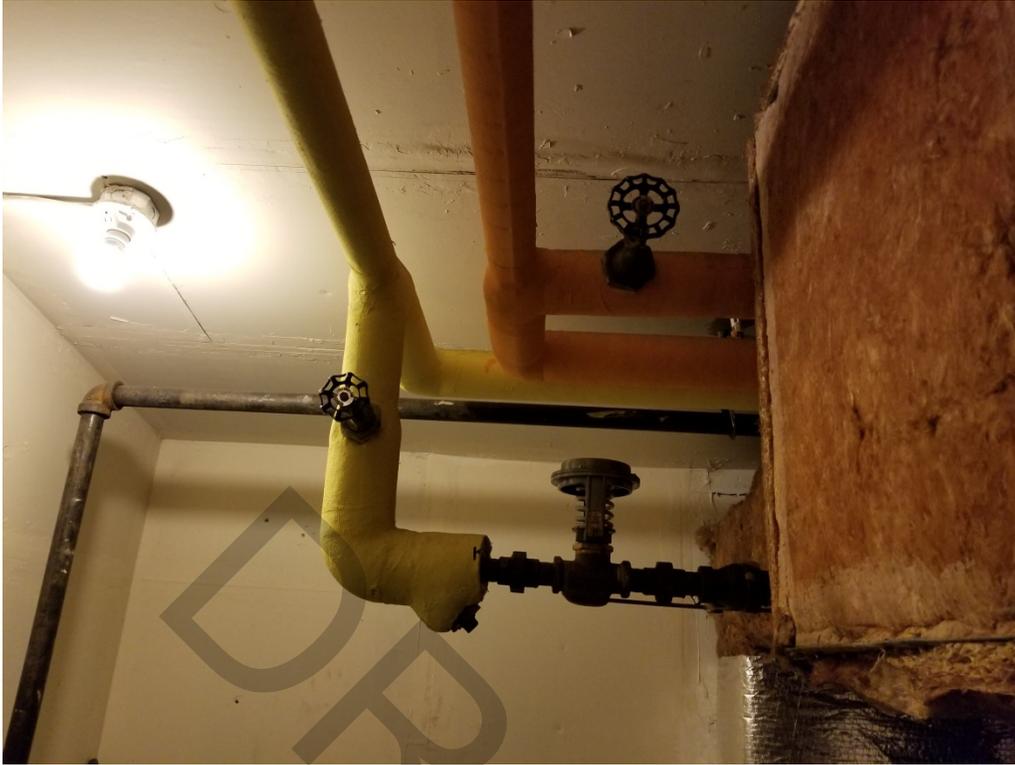
Photo 13: Presumed ACM TSI in the air handler room. Orange duct insulation on the right is not ACM. (May 22, 2018)

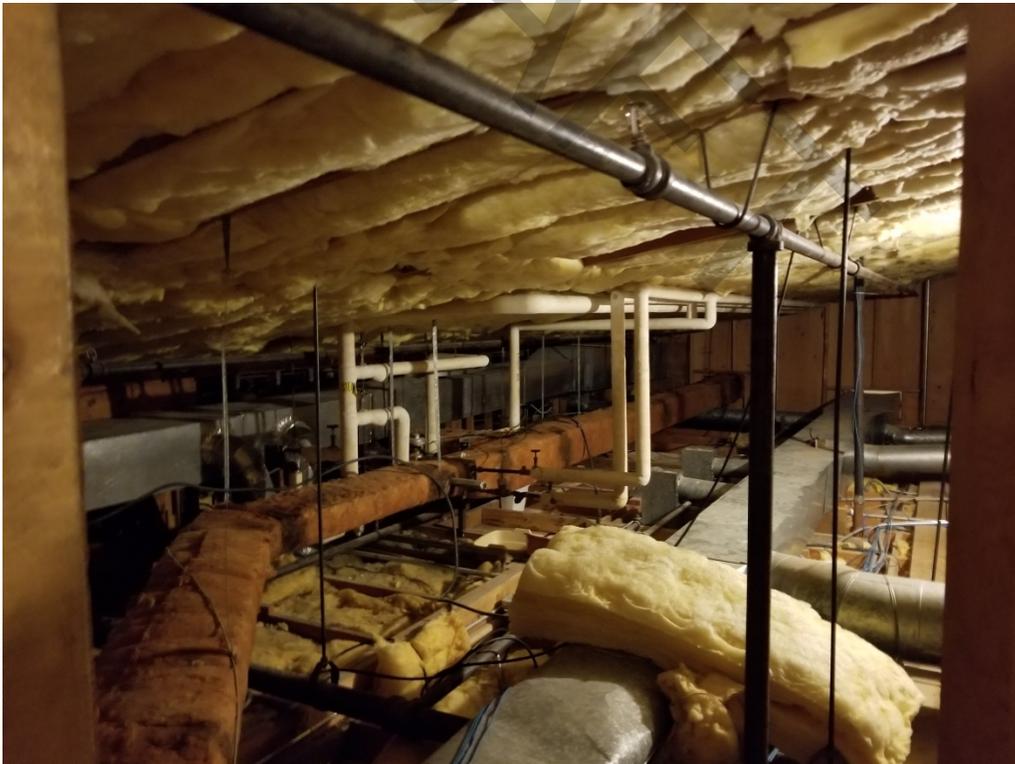
Photo 14: Presumed ACM TSI in the attic under the roof of the original building. (May 22, 2018)

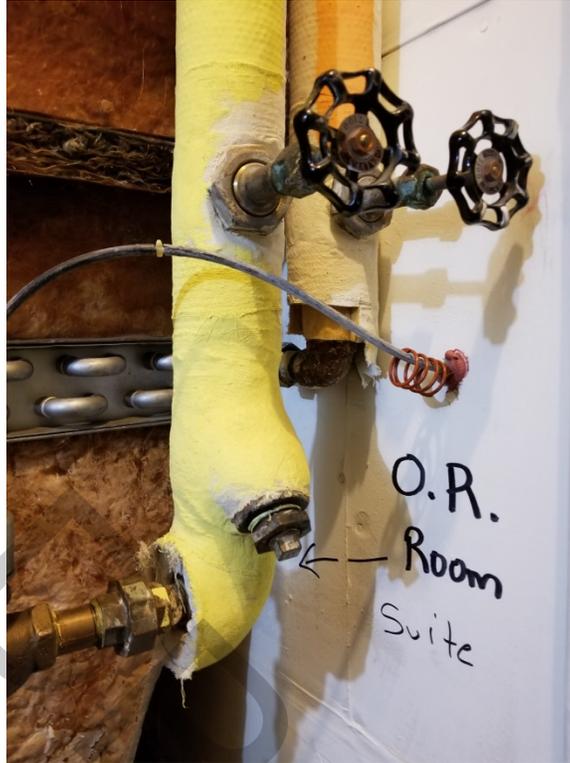
Photo 15: Exposed ends of presumed ACM TSI hard insulated joints. (May 22, 2018)
